Eagle Inspection Services, LLC

Property Inspection Report

123 ABC St, Auburn, AL 36832
Inspection prepared for: Andrew Barber
Date of Inspection: 8/16/2022 Time: 08:30 AM
Age of Home: 2010 Size: 3202 sqft
Weather: 83°/Sunny

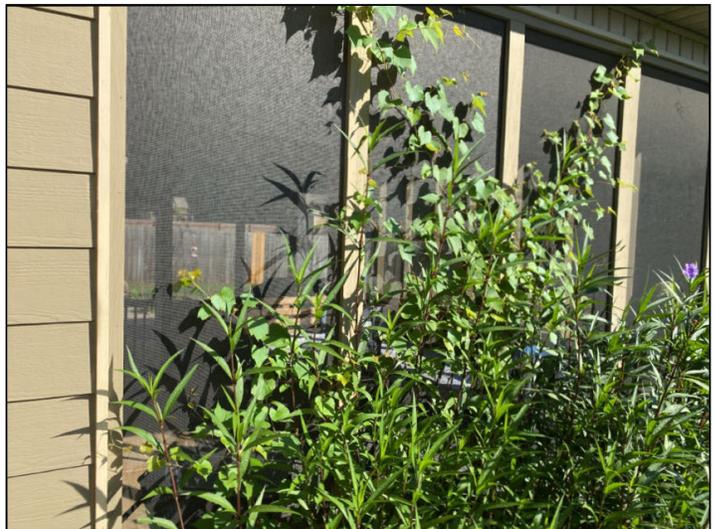
- **MAINTENANCE TIP:** When landscaping, keep plants, even at full growth, at least a foot (preferably 18 inches) from house siding and windows. Keep trees away from foundation and roof. Plants in contact or close proximity to the home can provide pathways for wood destroying insects and moisture, as well as abrade and damage siding, screens and roofs.
- There was vegetation touching the structure. I recommend pruning or removing any plants or trees that are in contact or close proximity to the home to eliminate pathways of wood destroying insects and moisture.

Vegetation touching structure

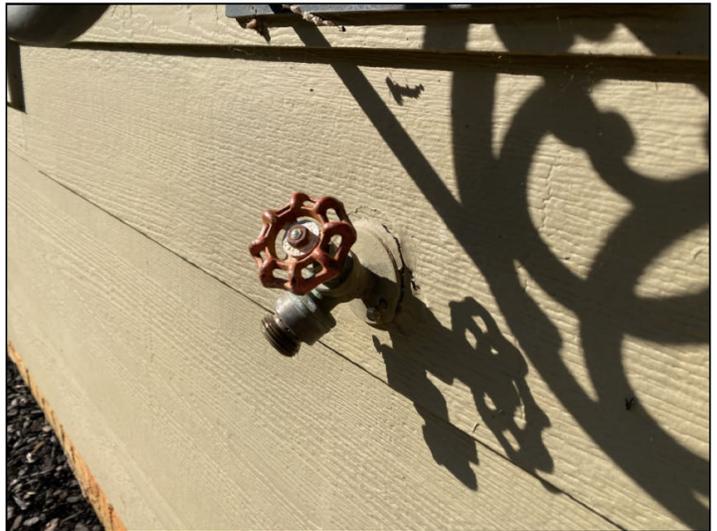
- The exterior faucets were loose at the structure. I recommend securing the faucets to prevent possible damage to the supply line.

Exterior faucet loose

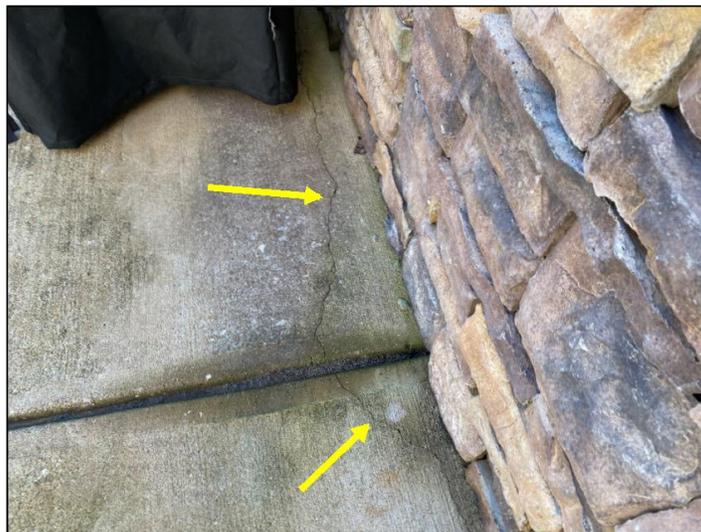
- Minor settlement, or "hairline" cracks noted. These should be monitored for expansion and sealed as necessary.

Typical concrete cracking

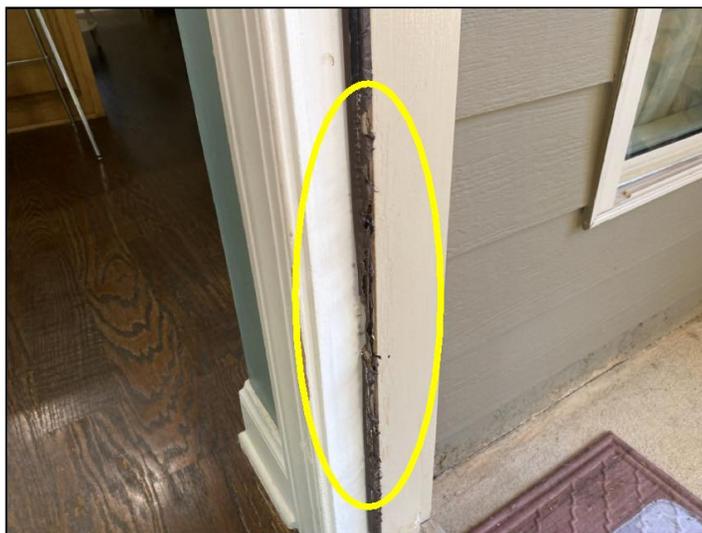
- The exterior doors were functional during the inspection.
- The exterior back door had damaged weatherstripping. I recommend repair as necessary to help with the efficiency of the home.

Damaged weatherstripping at back door

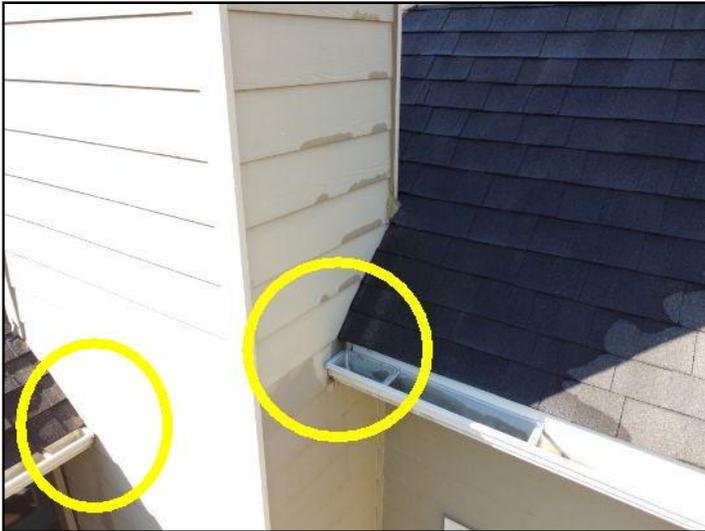
- The visible portions of the flashings were in acceptable condition. Most of the flashing was not visible due to being covered by the roof and siding.
- **UPGRADE:** There was no kickout flashing noted. Kickout flashing diverts rainwater away from the siding. I recommend installing kickout flashing to prevent moisture intrusion into the structure.

Missing kickout flashing

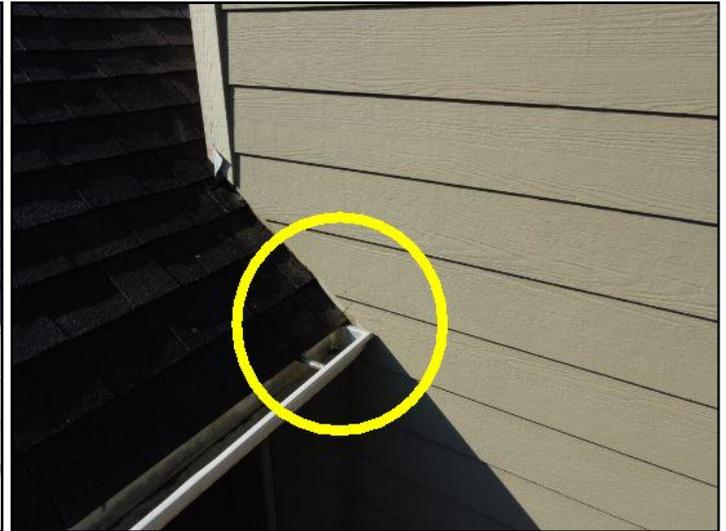
Missing kickout flashing

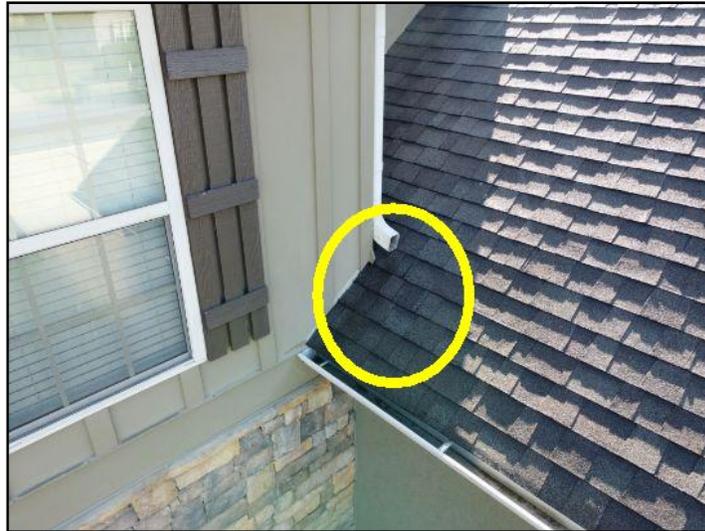
Downspout terminates onto roof surface

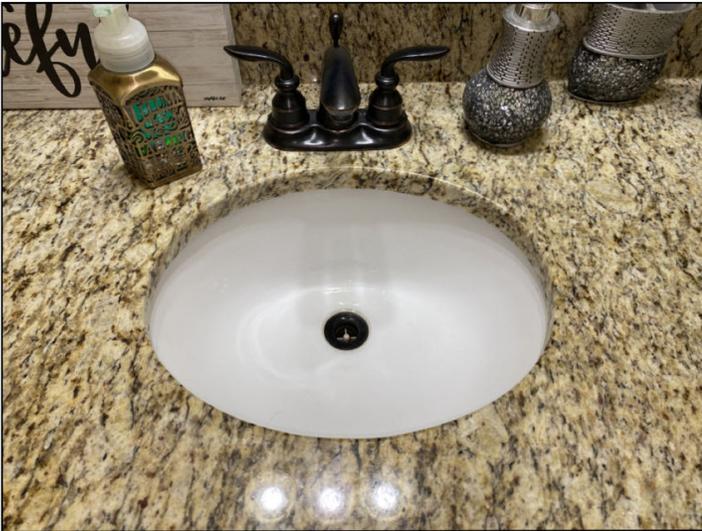
- The sinks were functional during the inspection.
- The bathroom sink stoppers were missing. I recommend correction for proper operation.

Sink stopper missing in downstairs bathroom #1

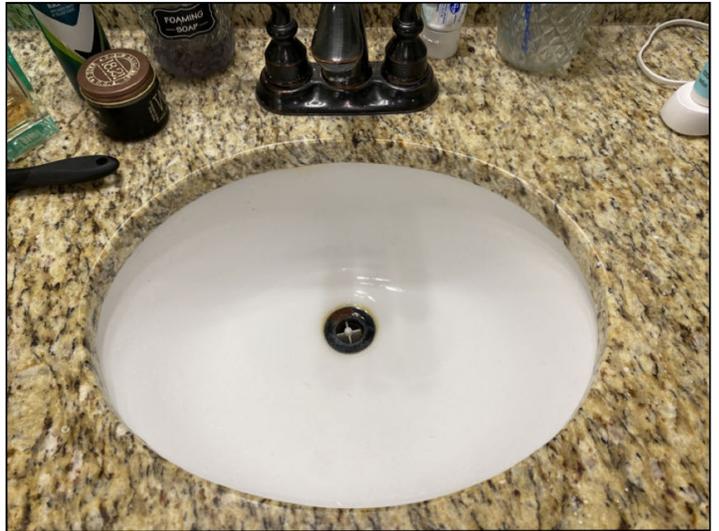
Sink stopper missing in downstairs bathroom #2

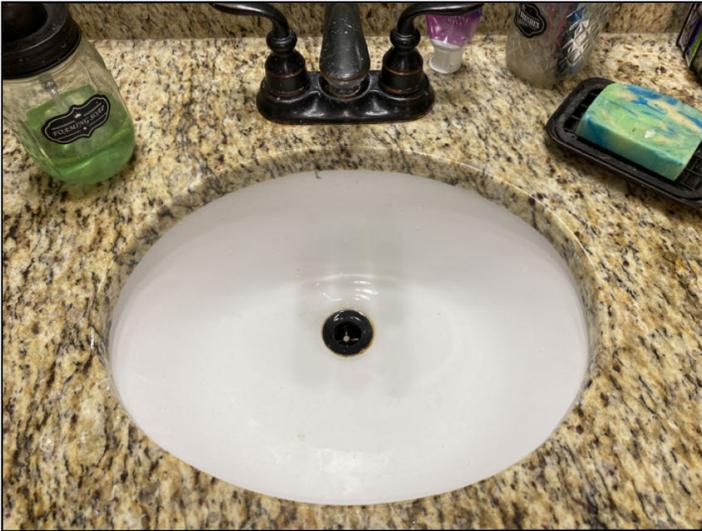
Sink stopper missing in downstairs bathroom #2

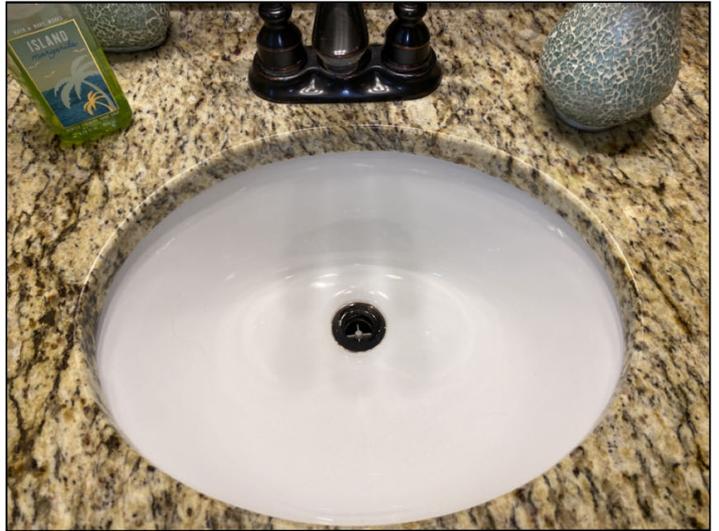
Sink stopper missing in upstairs bathroom #1

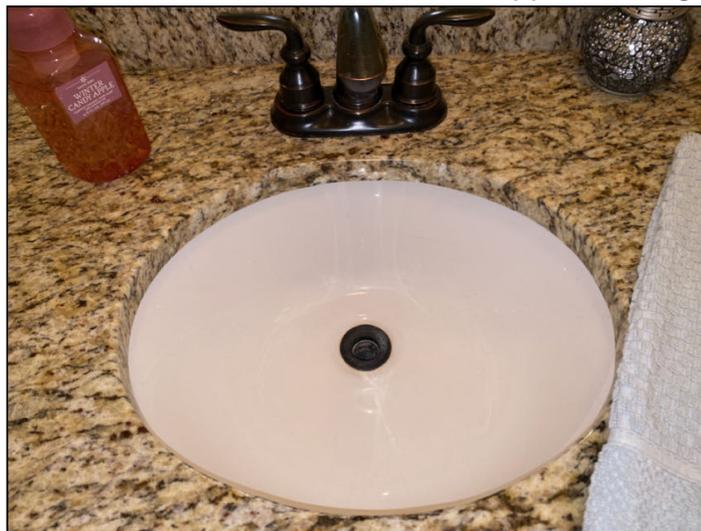
Sink stopper missing in upstairs bathroom #2

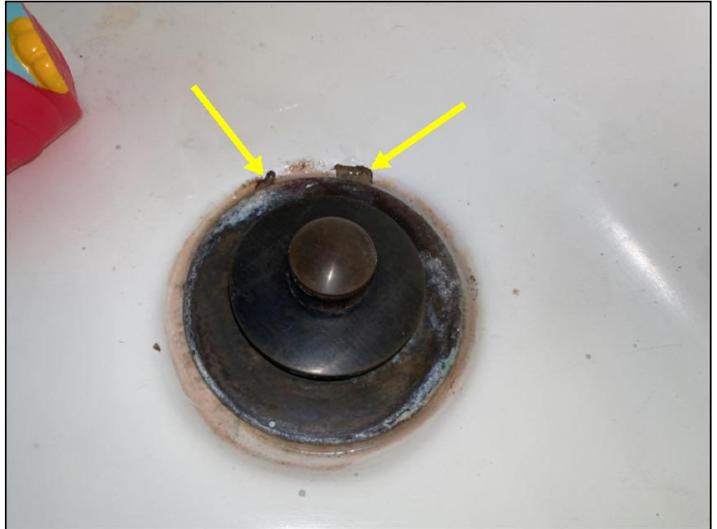
- The tubs were functional during the inspection.
- The stopper to the tub in upstairs bathroom #1 was inoperable at the time of the inspection. I recommend correction for proper operation.
- There were chips in the tub enamel in downstairs bathroom #2. I recommend repair to prevent damage.

Chips in tub enamel in downstairs bathroom #2

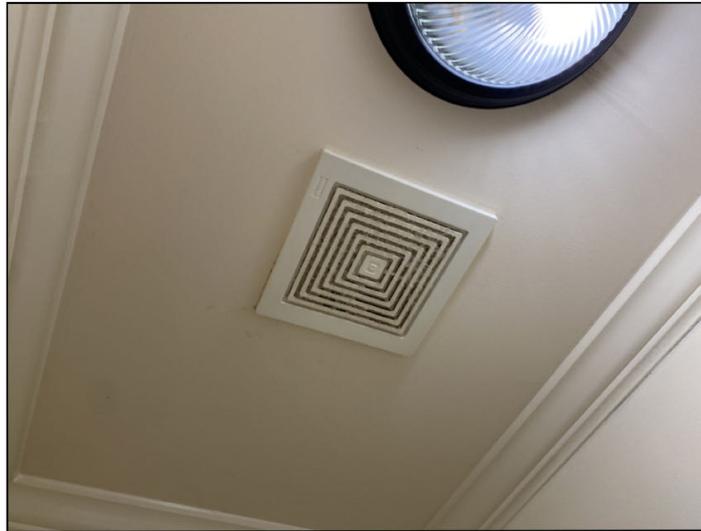
- The bath fans were functional during the inspection.
- MAINTENANCE: I recommend routine cleaning to prolong life and reduce noise.
- The bath fan in downstairs bathroom #2 vibrates or is excessively noisy. The fan may eventually need to be replaced to correct this condition.

Noisy bath fan in downstairs bathroom #2

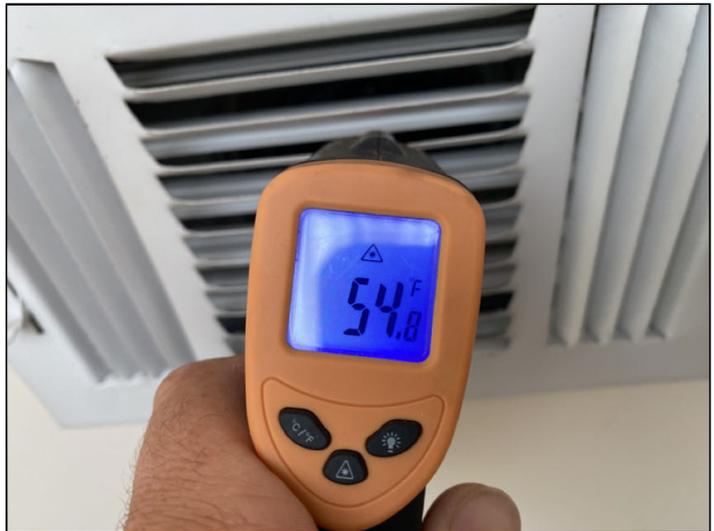
- The typical temperature differential split between supply and return air in air conditioners of this type is 15°-20°F.
- The upstairs A/C system responded and achieved an acceptable differential temperature of 18°F.
- **The downstairs A/C system failed by not achieving any drop in temperature. I recommend review by a qualified HVAC technician.**

Upstairs temperature drop

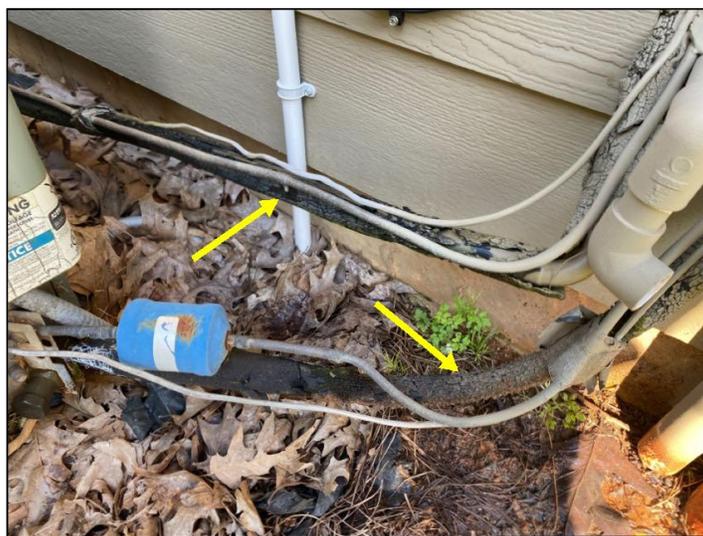
- No deficiencies noted at the visible portions of the refrigerant lines.
- **UPGRADE:** There was missing or damaged insulation at the refrigeration line. This can affect the efficiency of the system due to heat loss. I recommend installing insulation so that all of the line is covered.

Missing/damaged insulation on refrigerant line

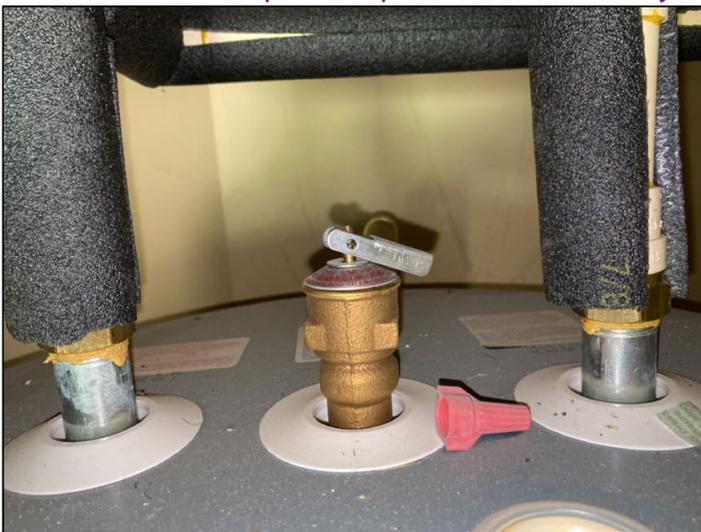
Water heater #1

- The **TPR valve** and discharge pipe appeared to be in satisfactory condition at the visible portions.
- **FYI:** The TPR valve discharge pipe for water heater #1 terminates in the garage. If water is ever observed leaking from this pipe, it can be an indication that this safety valve is failing and you should contact a qualified plumber immediately to evaluate the system.

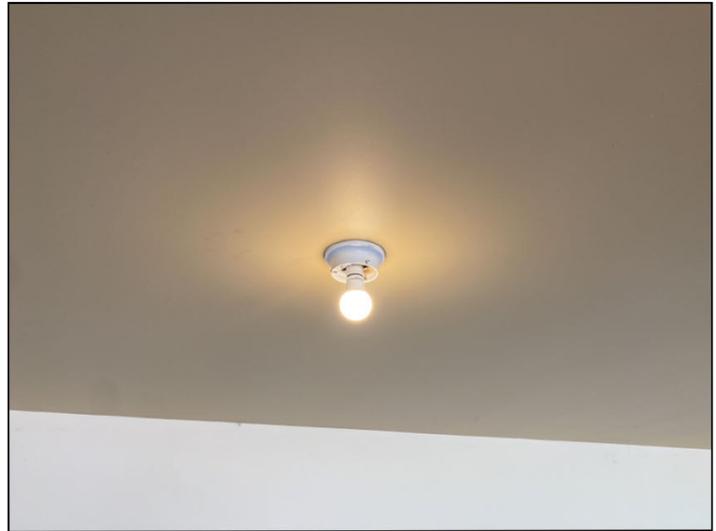
Garage light fixture globe missing
