# ***Eagle Inspection Services, LLC***

## **Property Inspection Report**

123 ABC St, Anytown, AL 36830  
Inspection prepared for: Andrew Barber  
Date of Inspection: 5/22/2022 Time: 8:30am  
Age of Home: 2018 Size: 2500 sqft  
Weather: 85°/Sunny

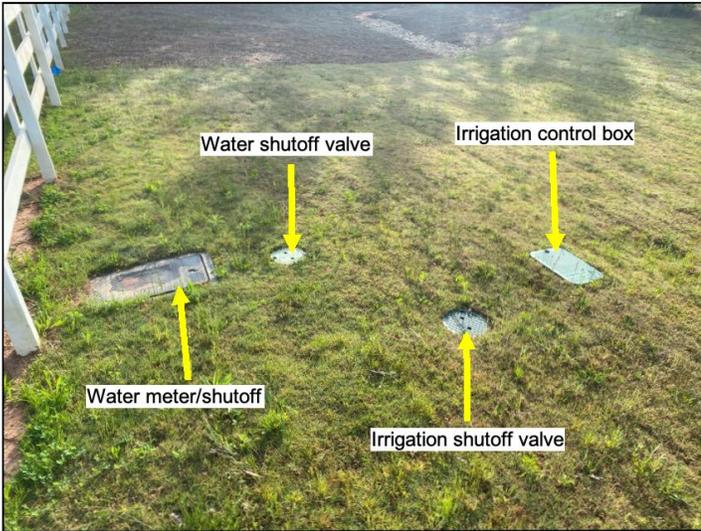
- The water meter/shutoff was located in the front yard.
- The **DWV** cleanout was located on the back side of the structure.
- Septic system noted. Septic systems are beyond the scope of a home inspection due to most of its parts/piping not visible for inspection. The client is advised to obtain any service history from the seller and seek the services of a specialist in evaluating this system.

Water meter/shutoff

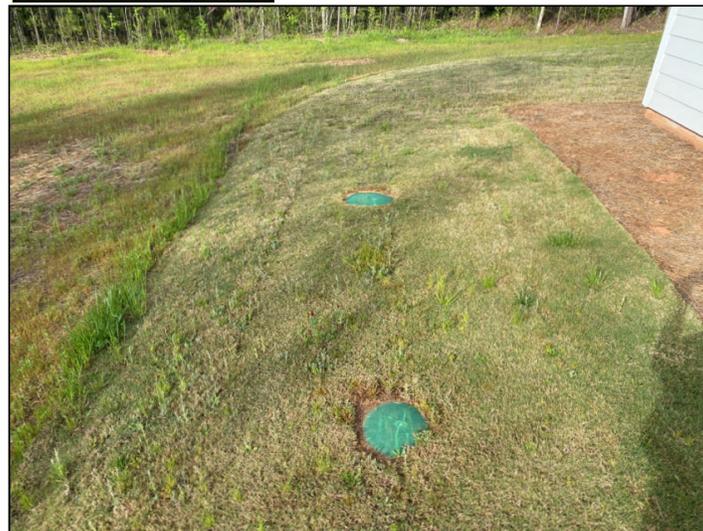
Septic system

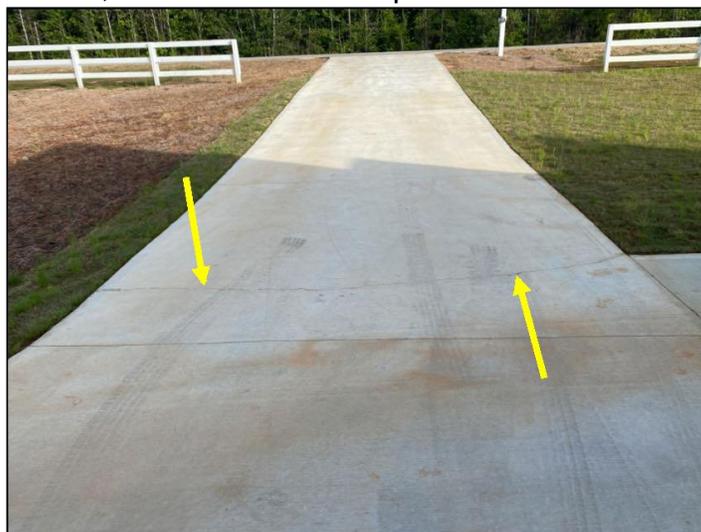
- The driveway and walkways were in acceptable condition with typical cracking observed.
- **MAINTENANCE:** Minor settlement, or "hairline" cracks in driveways are normal for properties of any age. They should, however, be monitored for expansion and sealed as necessary.

Typical concrete cracking

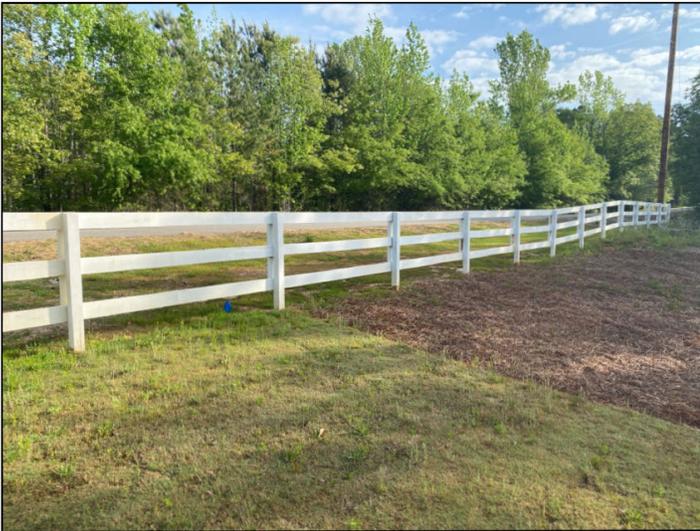
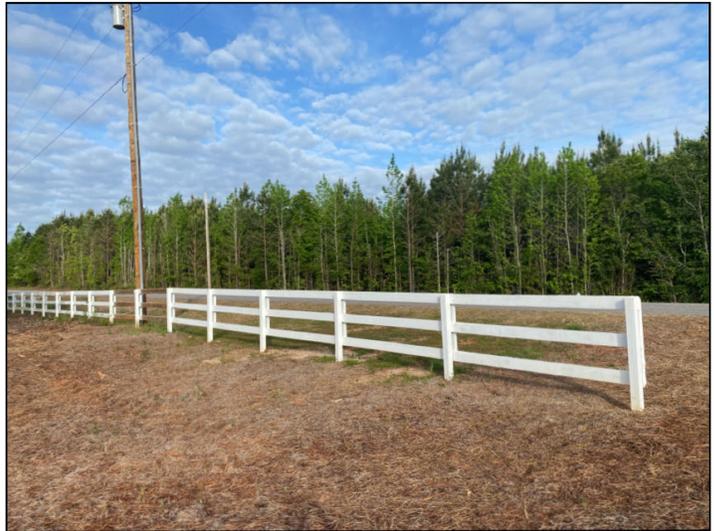
- Fences and gates are **NOT INCLUDED** as part of a home inspection under the Standards of Practice; however, as a courtesy I examined the visible parts of the fence and gate and found them to be in acceptable condition with no major repairs needed.

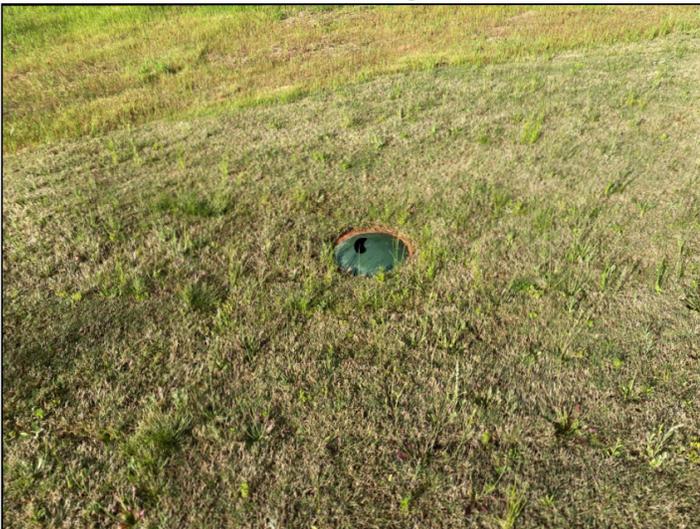
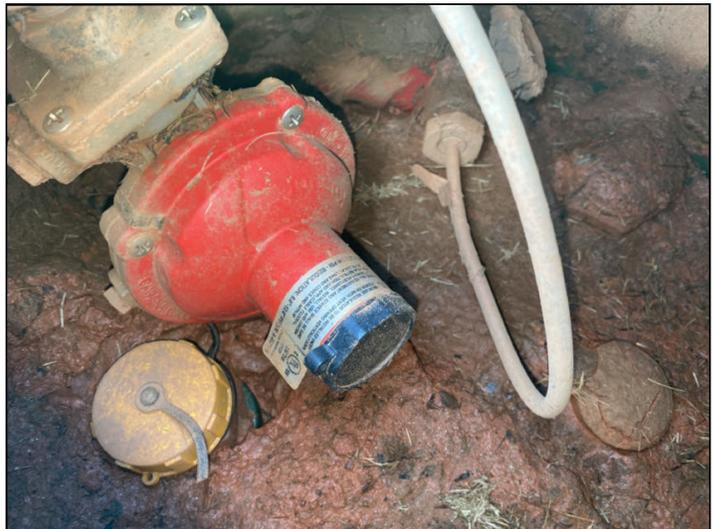
- No deficiencies noted. No gas odors detected.

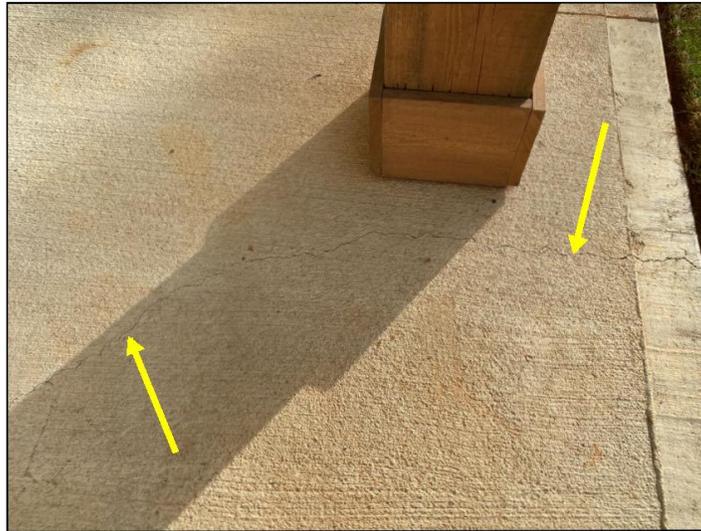
- Minor settlement, or "hairline" cracks noted. These should be monitored for expansion and sealed as necessary.

Typical concrete cracking

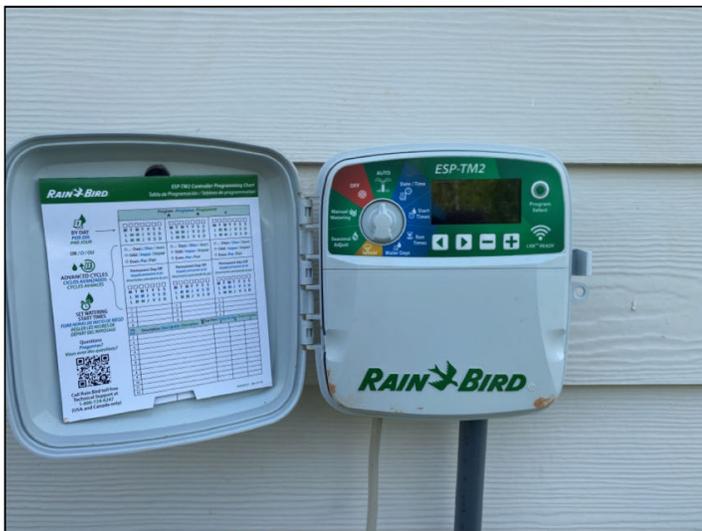
- The home was equipped with an underground irrigation system. Irrigation systems are beyond the scope of a home inspection, due to most of its parts/piping not visible for inspection; however, the irrigation system was tested for basic operation only at the control panel and was found to be operational. I recommend the client consult with the seller for operation instructions and proper winterizing information.
- The irrigation control box was loose on the wall. I recommend securing the box to prevent damage.

Irrigation control box loose on wall

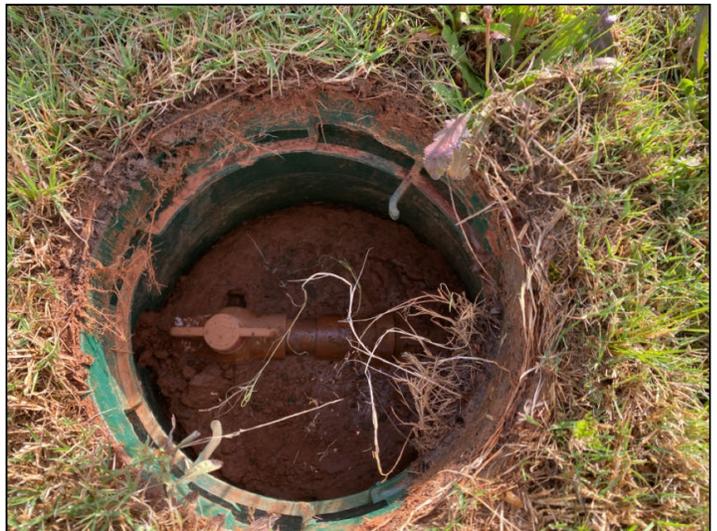
Irrigation shutoff valve

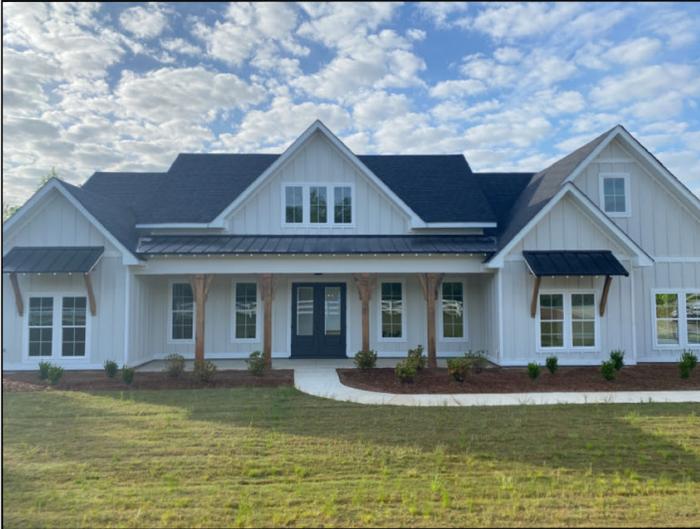
Front side

- The exterior siding was in acceptable condition.
- **MAINTENANCE:** I recommend routine monitoring of the caulking around doors, windows and siding. These areas should be properly sealed to prevent moisture intrusion and keep hot and cold air inside during the respective winter and summer months.

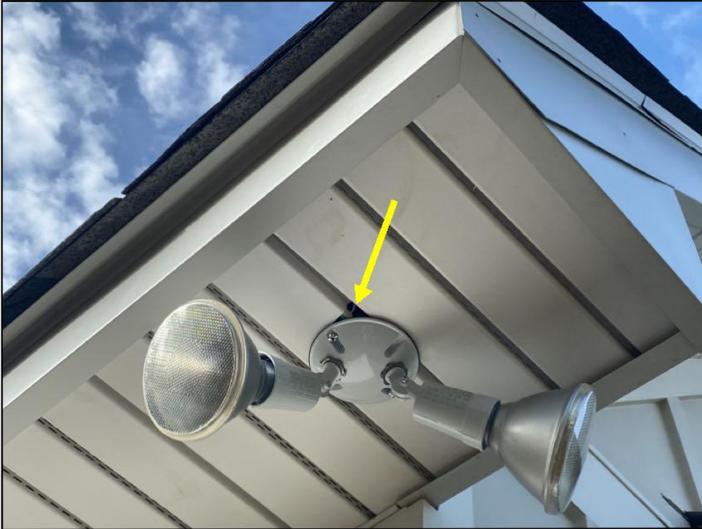
- There were several gaps in the eaves and around the front awnings. I recommend sealing these gaps to prevent moisture and pest intrusion.

Gap in eave around floodlight

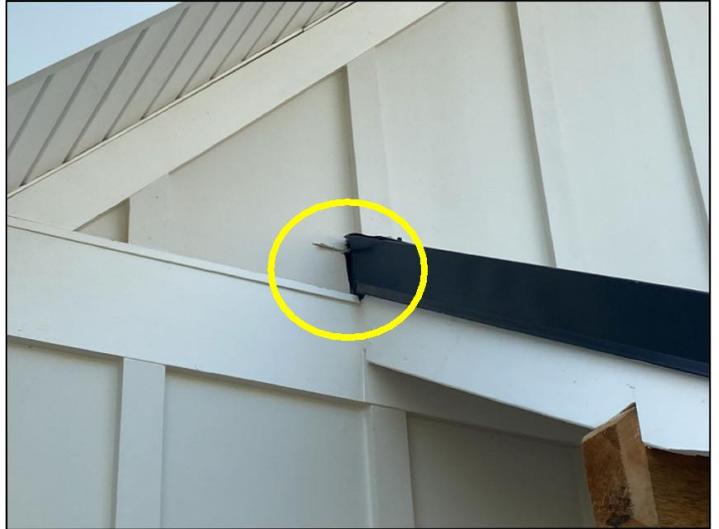
Gap in siding

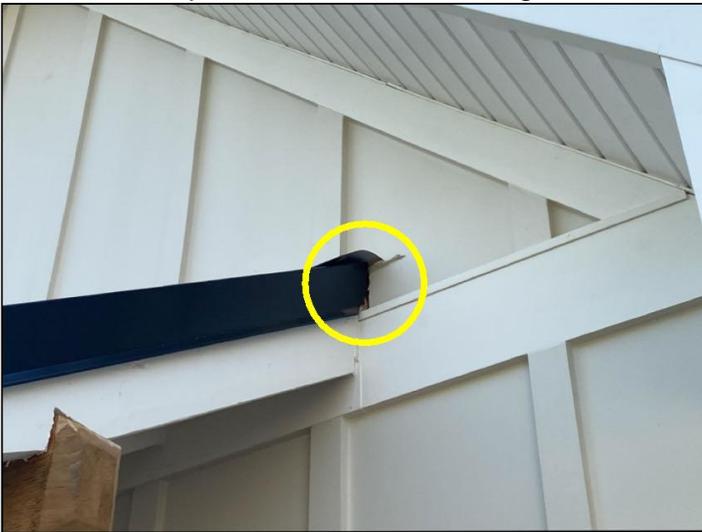
Gap in siding

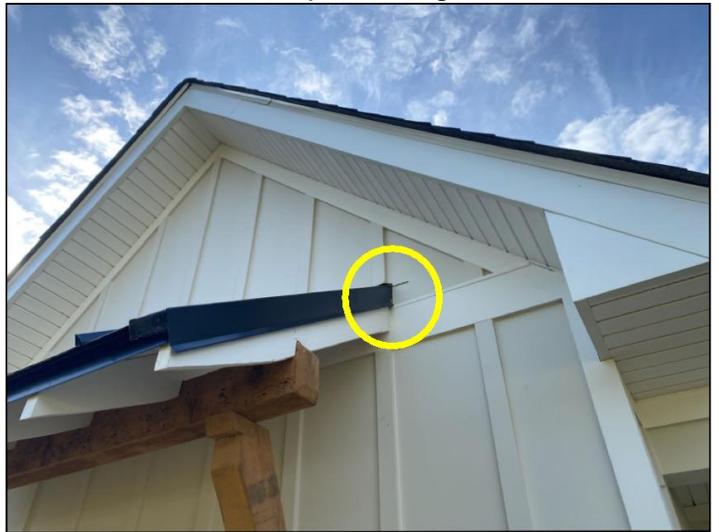
Gap in siding

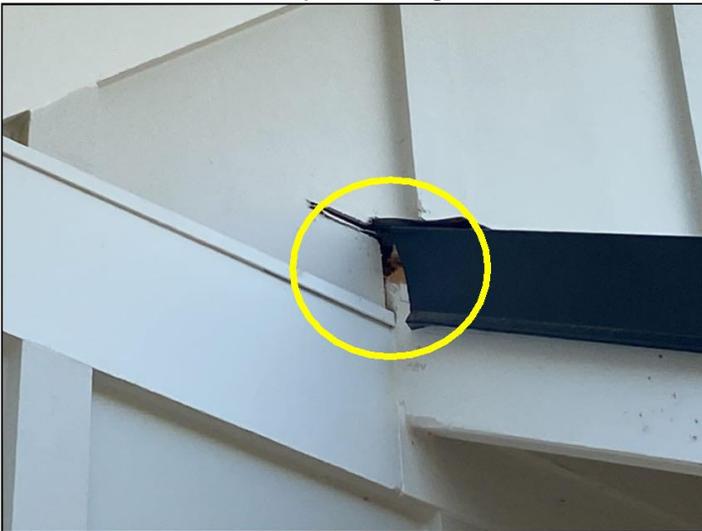
Gap in siding

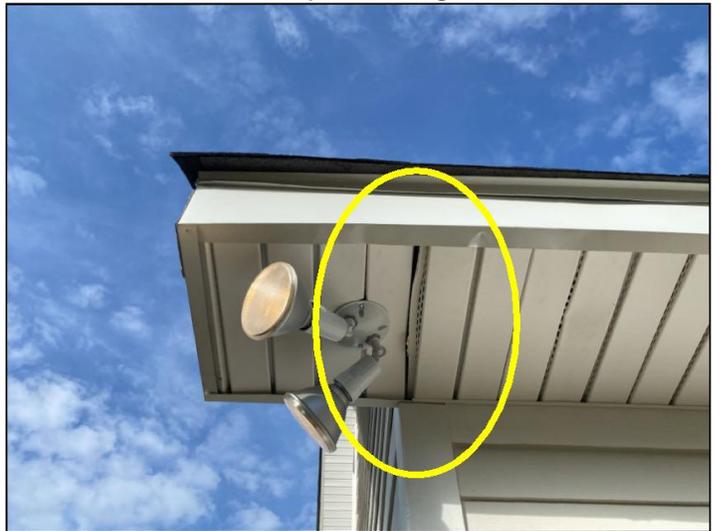
Gap in eave around floodlight

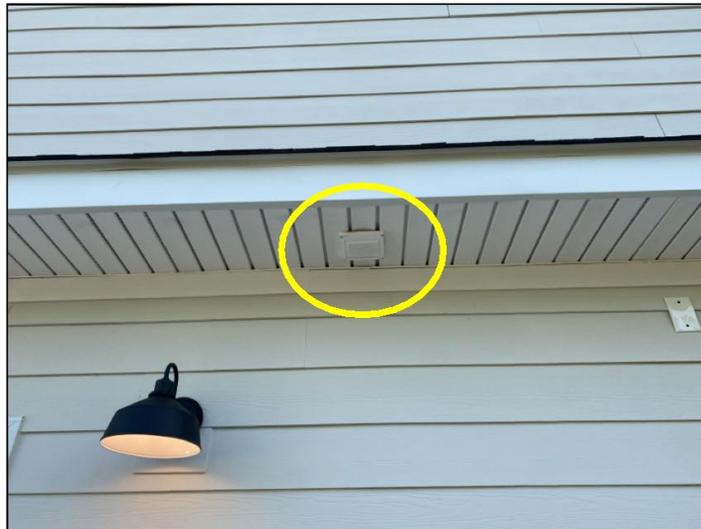
- I was unable to determine where the exterior dryer vent terminates. If the termination vent is the one in the photo, then the cover is wrong and should be replaced with a proper cover. I recommend consulting with the seller for its location, and routine maintenance to prevent lint buildup.

Unable to determine where exterior dryer vent terminates

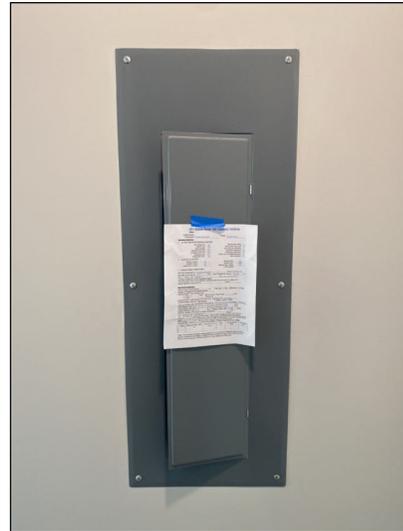
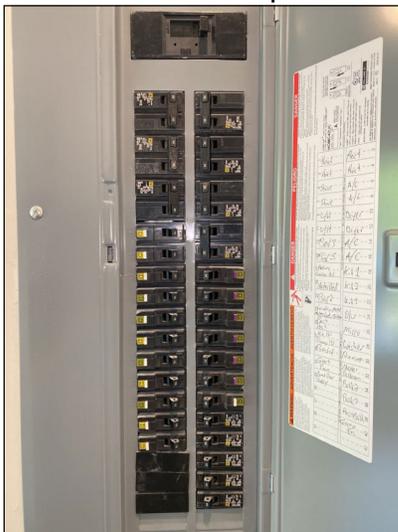
Sub electrical panel

- There was an exposed wire end in the sub electrical panel box. This is an electrocution hazard if the wire becomes energized. I recommend properly terminating the wire for safety.

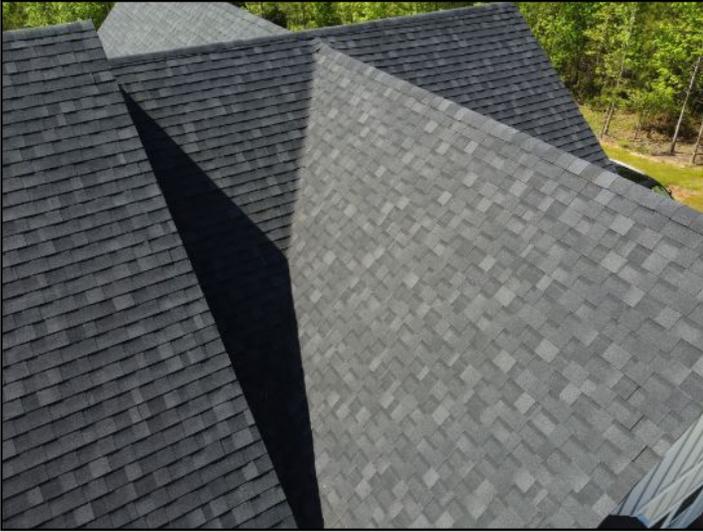
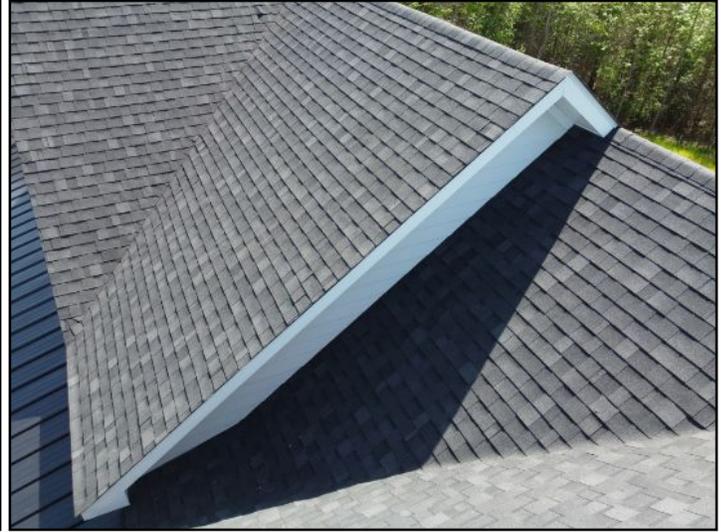
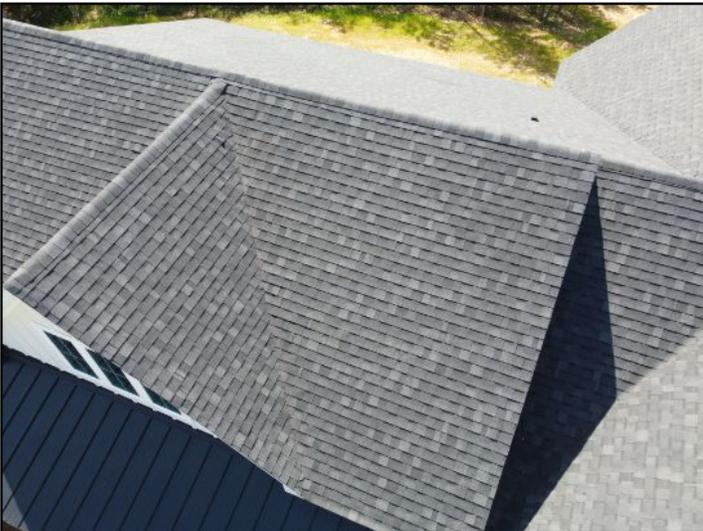
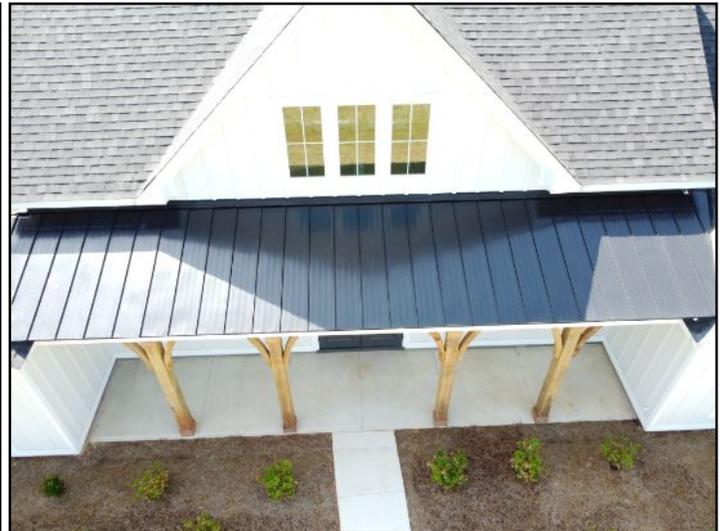
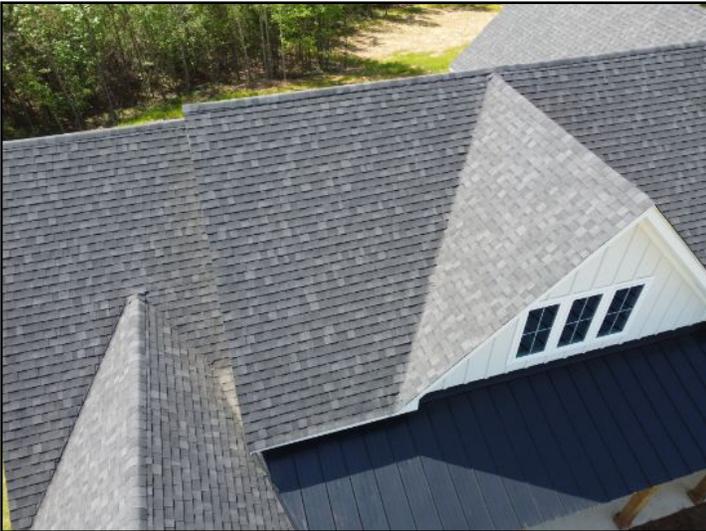
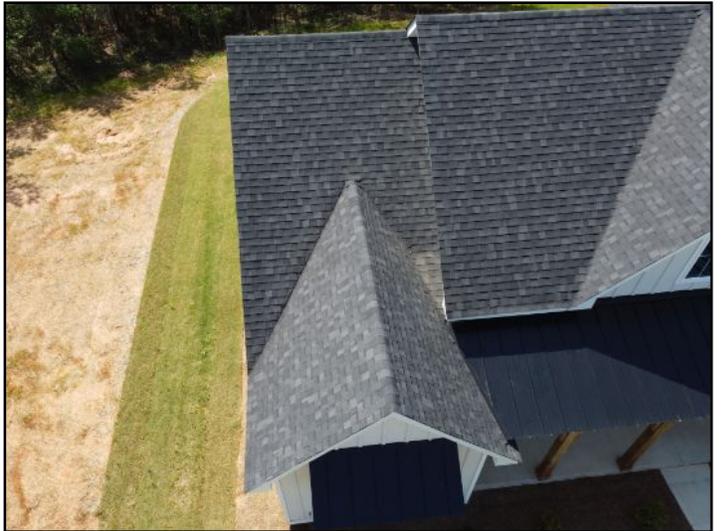
- Architectural asphalt shingles noted.
- Metal standing seam roofing noted.

- The roof was a new installation with no major deficiencies noted.
- **MAINTENANCE:** Roof systems should be periodically cleaned and maintained. Proper maintenance of the roof will help prolong the life of the surfaces.

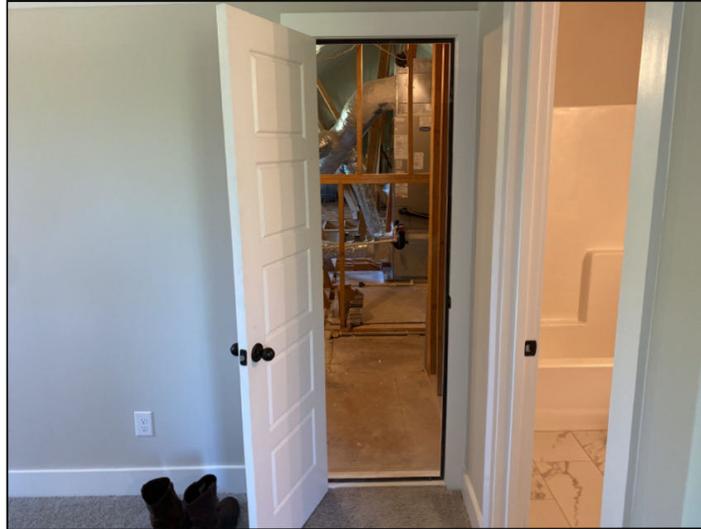
- There was an access door located upstairs.

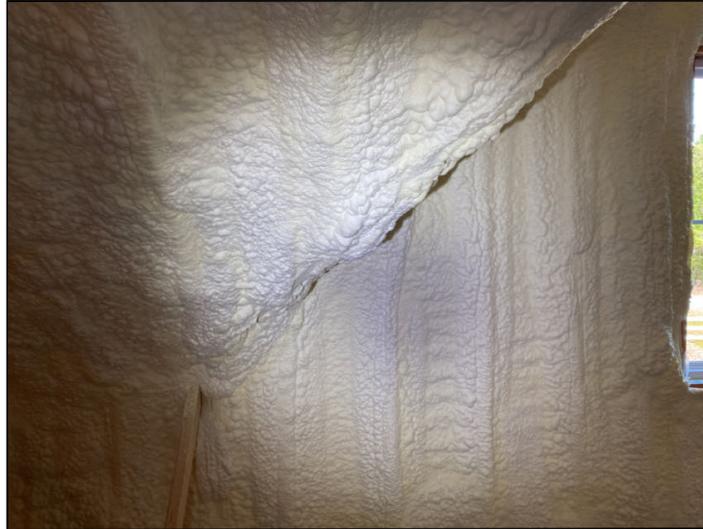
- The insulation level in the attic is typical for homes of this type.

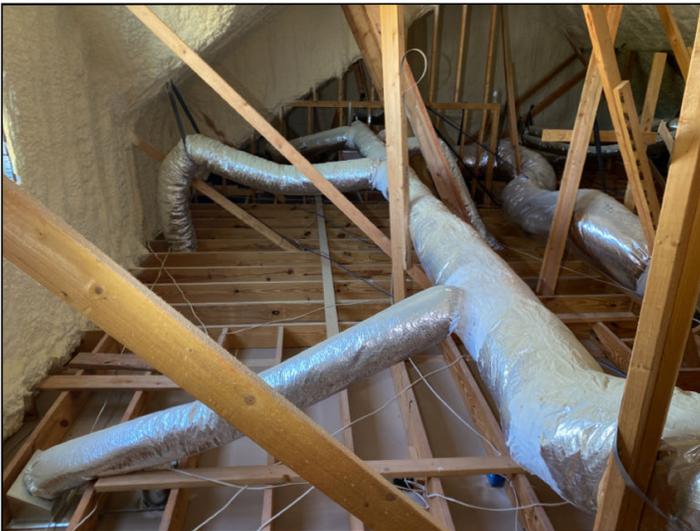
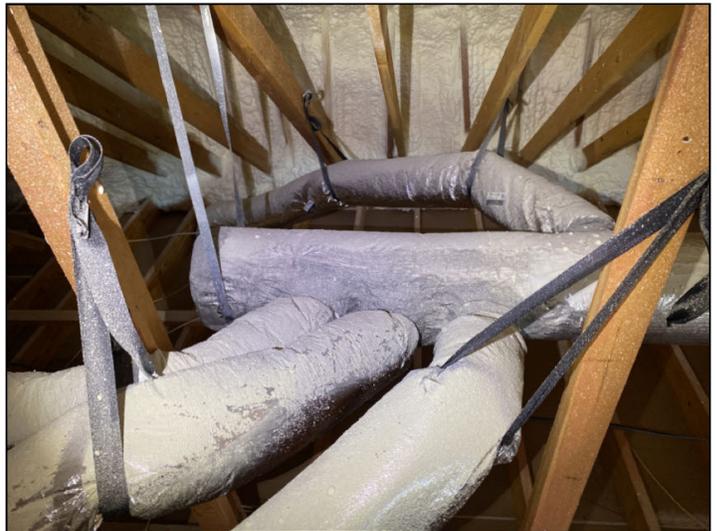
- There was an electrical wire in the attic that was cutting off the flow of ductwork at a supply register. I recommend correction for proper operation.

Electrical wire cutting off ductwork in attic

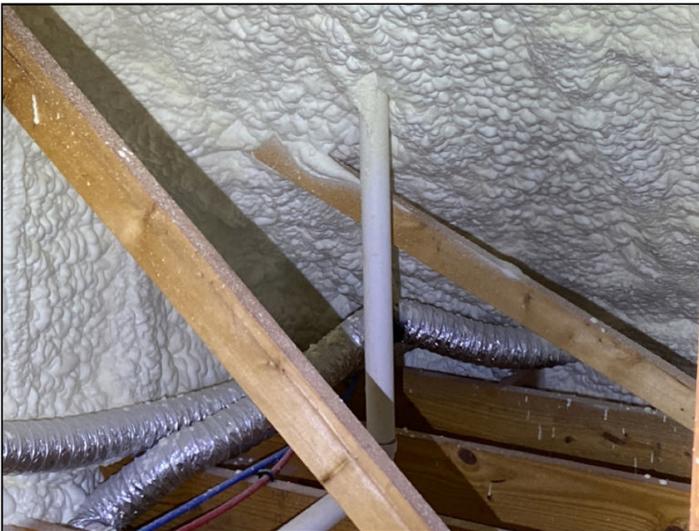
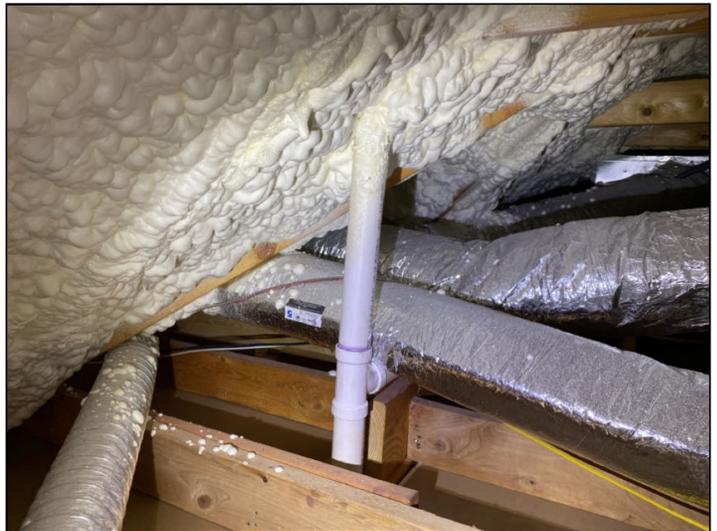
- No deficiencies noted in plumbing vent piping.

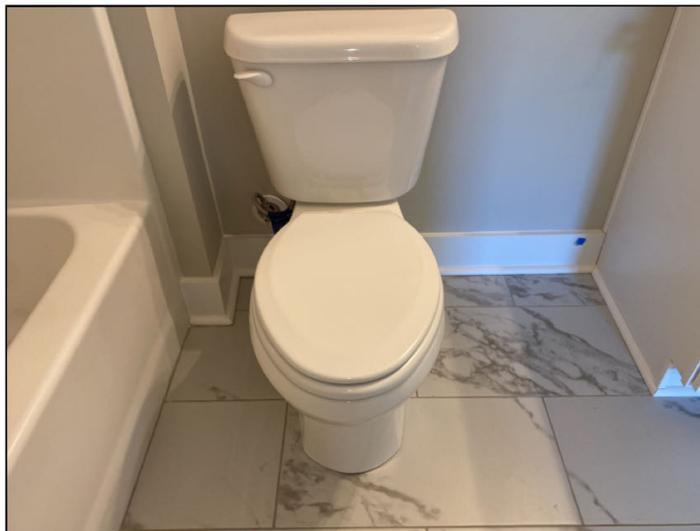
- The toilets were functional during the inspection.
- The toilet bowl in the upstairs bathroom was loose at the floor. The wax ring inside the unit must have a snug, secure fit in order to keep from leaking. Properly resealing and resecuring this unit is suggested to prevent water leakage and damage to the subfloor area. This is usually easily accomplished by tightening the two bolts at the base of the toilet or by adding shims. I recommend review by a qualified plumber if necessary.

Loose toilet in upstairs bathroom

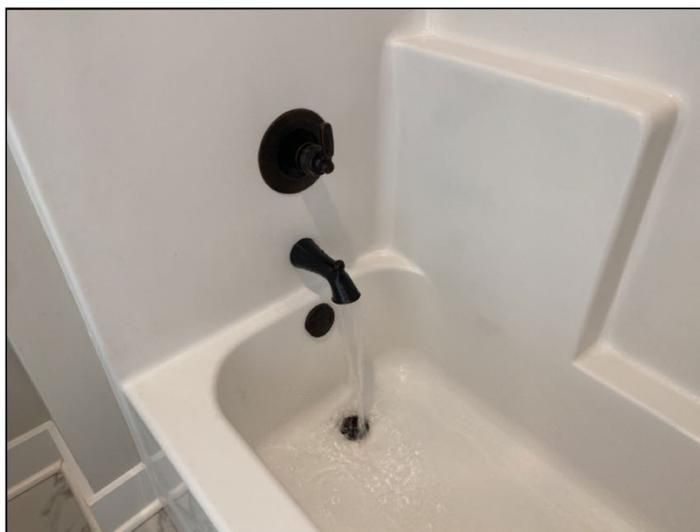
- The tub(s) were functional during the inspection.
- The tub water never got hot in downstairs bathroom #2. I recommend repair for proper operation.

Tub water never got hot in downstairs bathroom #2

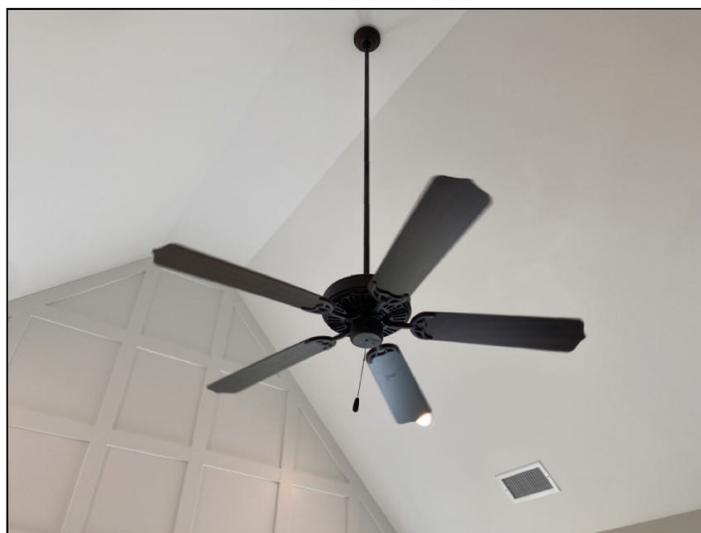
- The ceiling fans operated when tested. No deficiencies found, except where noted.
- The ceiling fan motor was loose in the master bedroom. I recommend securing the motor to prevent damage.

Ceiling fan motor loose in master bedroom

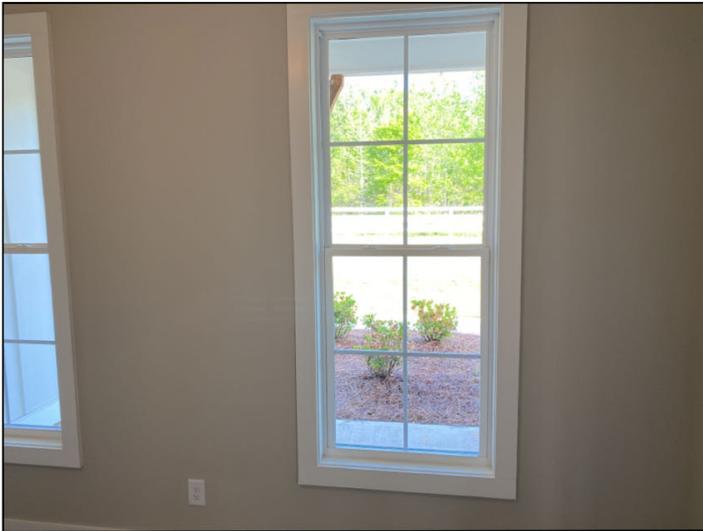
- Operated when tested. No deficiencies found, except where noted.
- The window in downstairs bedroom #1 did not open properly and would not stay open. I recommend correction for proper operation.
- The left side window in downstairs bedroom #3 would not stay open. I recommend repair for proper operation.

Window did not function properly in downstairs bedroom #1

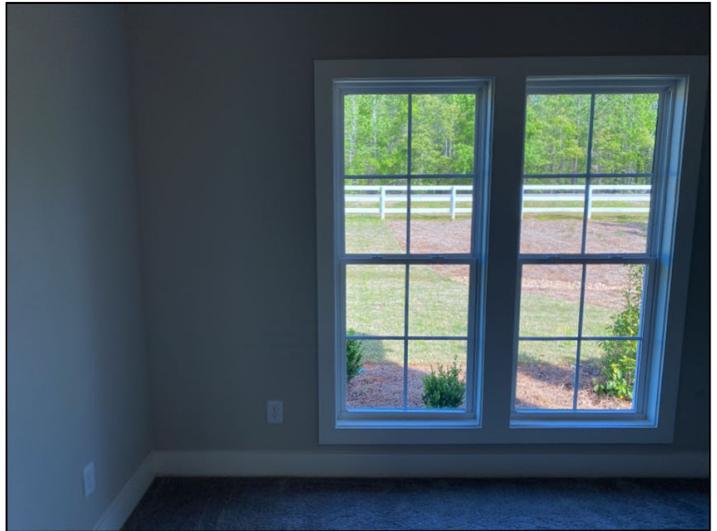
Left side window would not stay open in downstairs bedroom #3

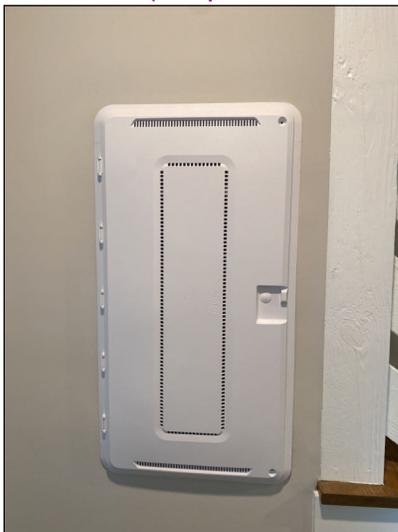
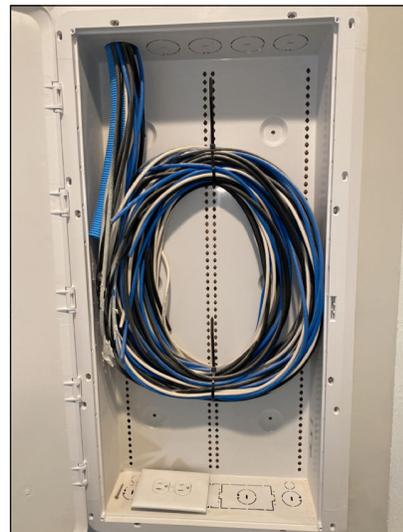
- FYI: The Open House panel located next to the laundry room is a wiring panel for all the audio and communication (telephone, data, TV) wiring in the house.

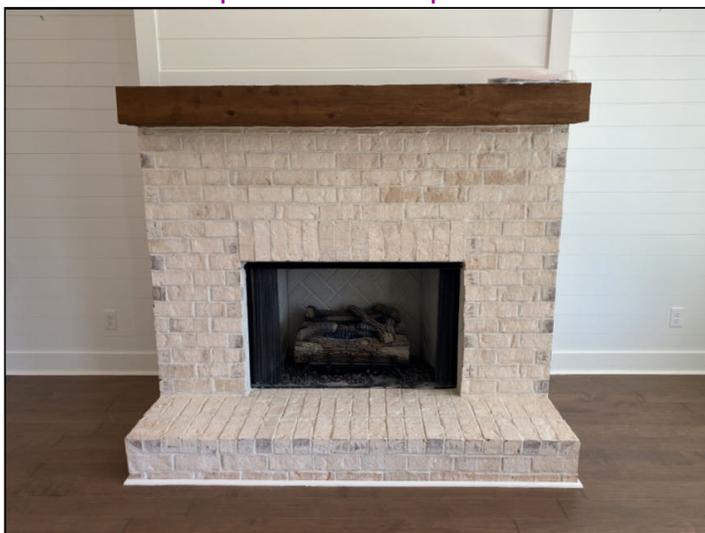
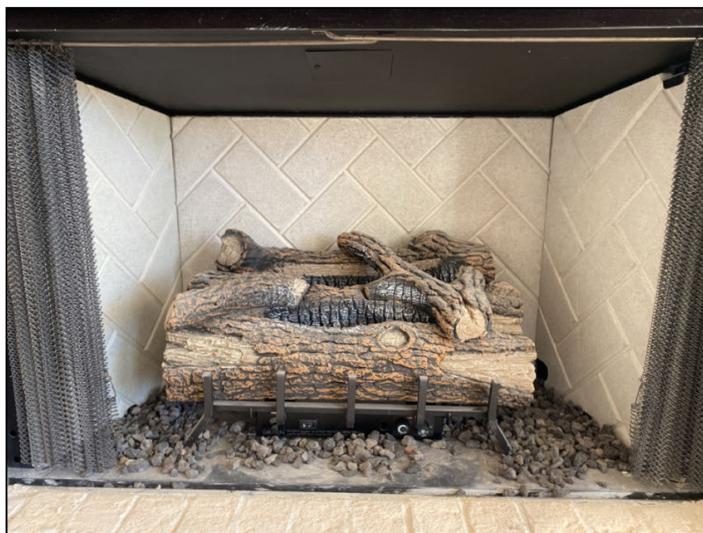
- FYI: I was unable to fully inspect the gas fireplace because the gas to the fireplace was shut off at the time of the inspection. In accordance with the Standards of Practice this inspection was performed under; I am unable to operate shutoff valves. I recommend checking for proper function prior to closing.
- MAINTENANCE: Gas fireplaces should be cleaned and inspected annually. I recommend a qualified plumber or HVAC technician inspect and clean the fireplace prior to use each season.
- FYI: A ventless gas fireplace was present, which vents combustion products directly into the living space. Manufacturers generally recommend not running ventless fireplaces for more than 2-3 hours at a time. These units are not designed to be a primary source of heat and should only be installed and operated in complete accordance with the manufacturer's recommendations.

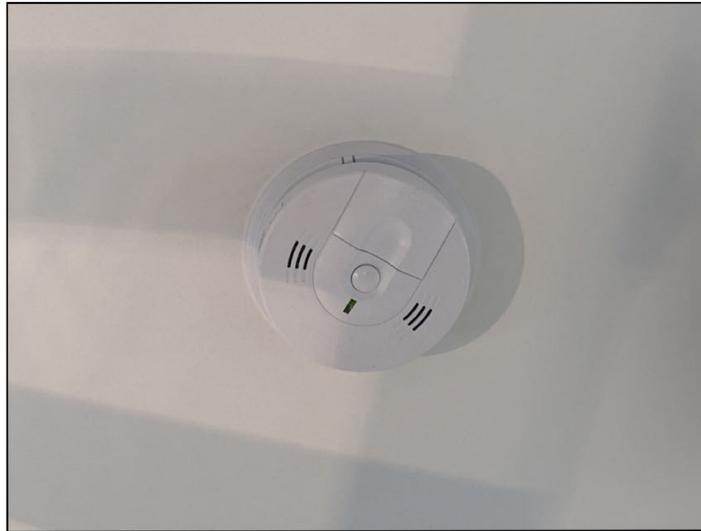
- Smoke/CO detectors were present and functional at the time of the inspection.
- MAINTENANCE: I recommend Smoke/CO detectors be tested and have batteries changed twice yearly. It is recommended that Smoke/CO detectors be installed and maintained on every level of the home, in every bedroom, and outside each sleeping area.

Smoke/CO detector

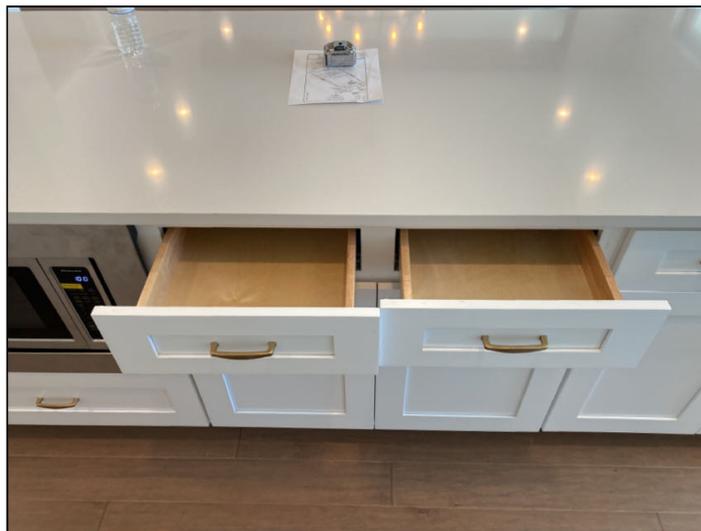
- The cabinets and drawers were functional during the inspection.
- Two drawers next to the microwave rubbed each other. I recommend correction to prevent damage.

Drawers rub each other

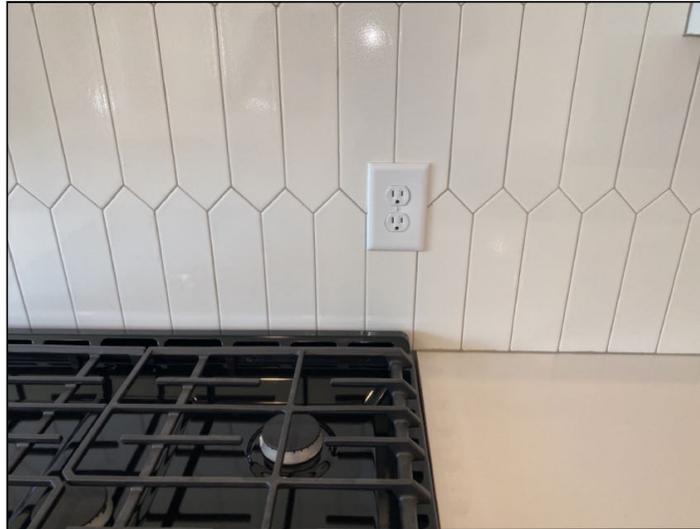
- FYI: The electrical outlet right of the cooktop was abnormally close to the gas burner. While this installation meets minimum code, I urge caution if using the outlet and cooktop at the same time.

Outlet behind cooktop

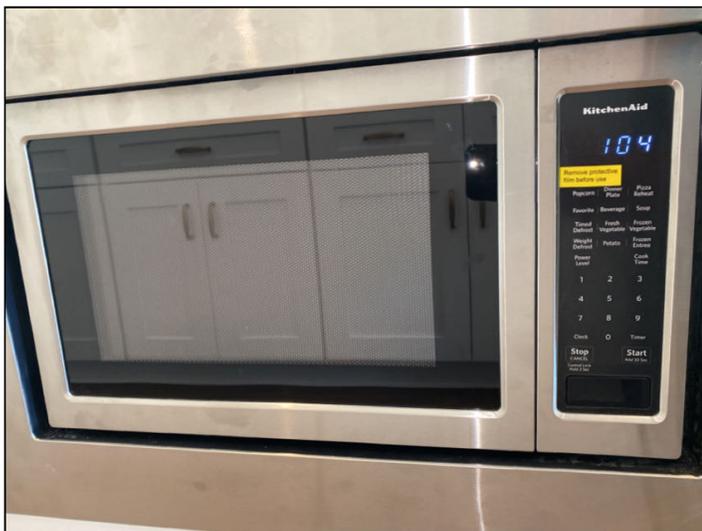
- The frame around the microwave was not secure. I recommend securing the frame to prevent damage.

Microwave frame not secure

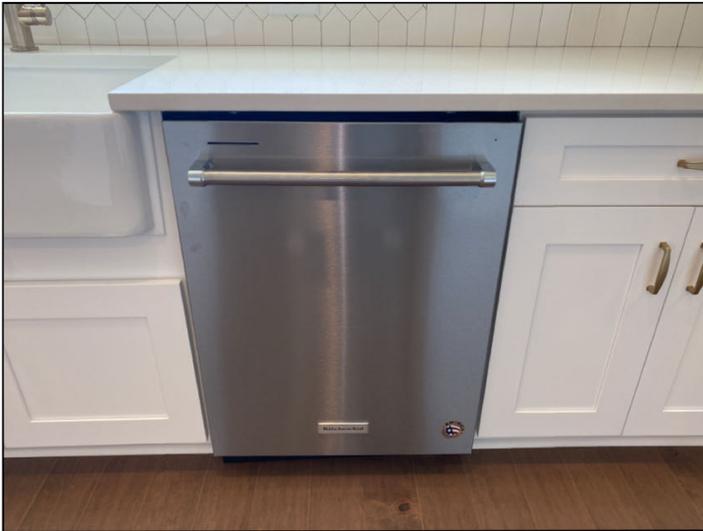
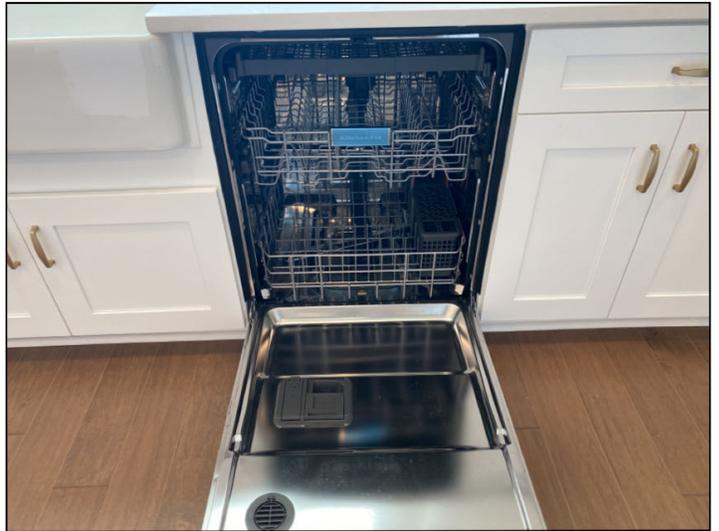
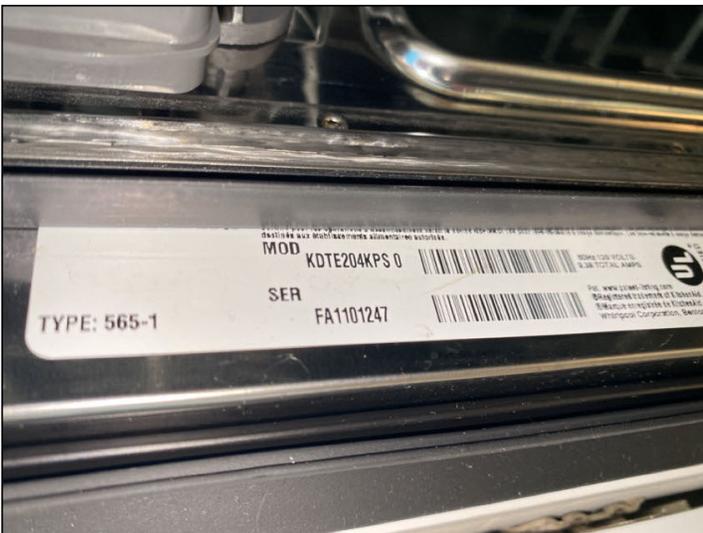
- The dishwasher was functional and in adequate condition. I cannot determine the efficiency of the appliance.
- There was a **high loop** installed in the dishwasher drain line; however, it appeared to be improper. The drain line has a sag in it that will hold water and cause odor and bacteria. I recommend installing a proper high loop with no sag for safety.

Improper high loop

Interior Areas		
Page 29 Item: 5	Ceiling Fans	<ul style="list-style-type: none"> <li>The ceiling fan motor was loose in the master bedroom. I recommend securing the motor to prevent damage.</li> </ul>
Page 29 Item: 9	Window Condition	<ul style="list-style-type: none"> <li>The window in downstairs bedroom #1 did not open properly and would not stay open. I recommend correction for proper operation.</li> <li>The left side window in downstairs bedroom #3 would not stay open. I recommend repair for proper operation.</li> </ul>
Kitchen		
Page 32 Item: 1	Cabinets	<ul style="list-style-type: none"> <li>Two drawers next to the microwave rubbed each other. I recommend correction to prevent damage.</li> </ul>
Page 33 Item: 5	Microwave	<ul style="list-style-type: none"> <li>The frame around the microwave was not secure. I recommend securing the frame to prevent damage.</li> </ul>
Page 34 Item: 8	Dishwasher	<ul style="list-style-type: none"> <li>There was a <b>high loop</b> installed in the dishwasher drain line; however, it appeared to be improper. The drain line has a sag in it that will hold water and cause odor and bacteria. I recommend installing a proper high loop with no sag for safety.</li> </ul>

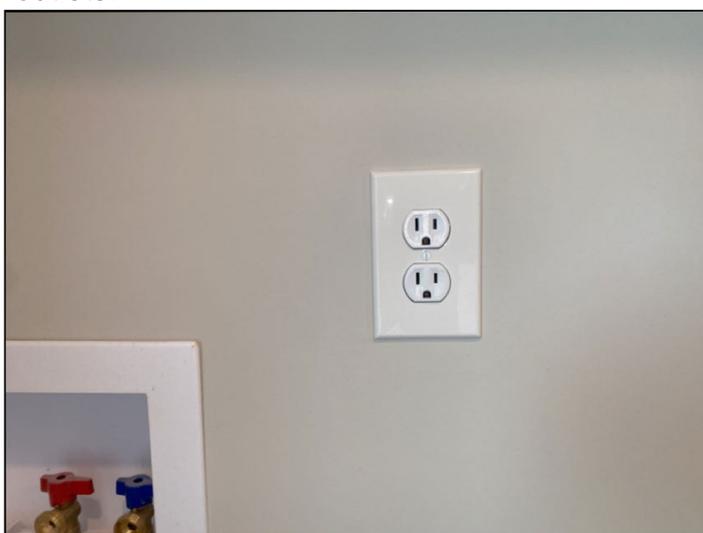
- No deficiencies noted with the 120/volt washing machine and 240/volt 4-prong dryer electrical outlets.

120/volt washing machine electrical outlet

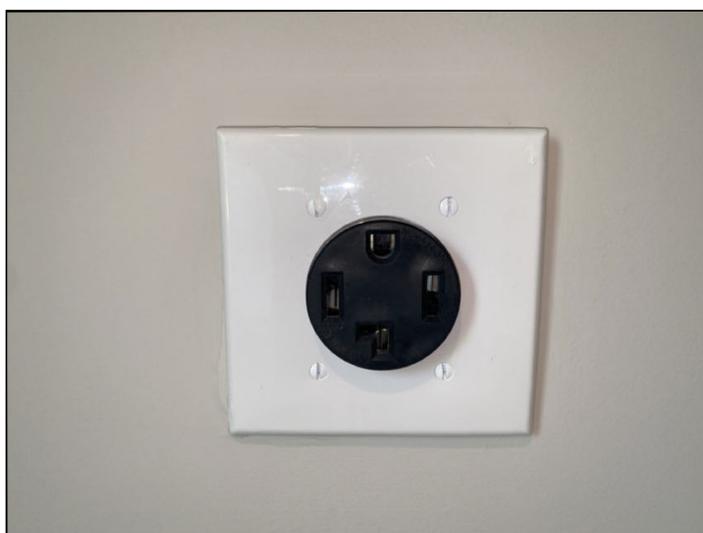
240/volt 4-prong dryer electrical outlet

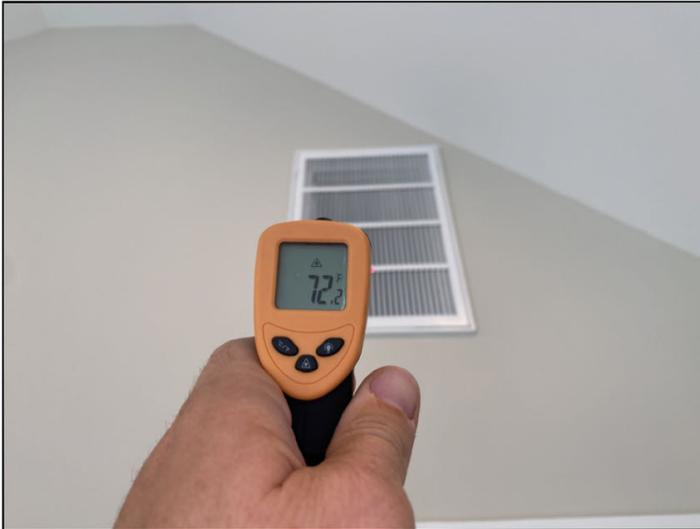
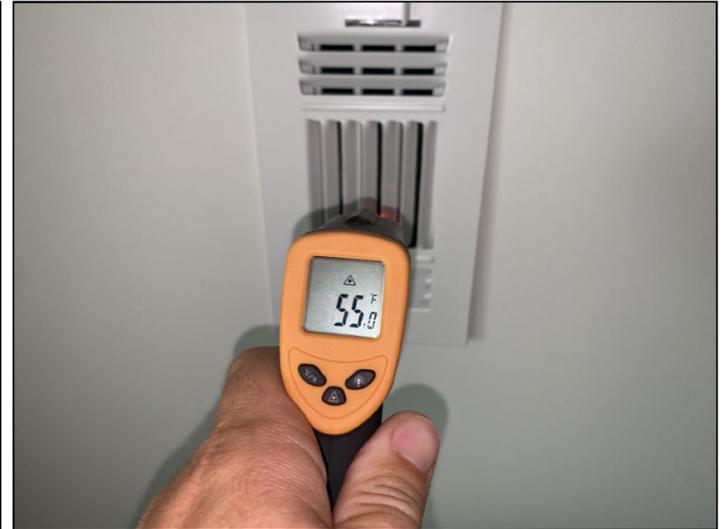
- The typical temperature differential split between supply and return air in air conditioners of this type is 15°-20°F.
- The left side downstairs A/C system responded and achieved an acceptable differential temperature of 15°F.
- The right side downstairs/upstairs A/C system responded and achieved an acceptable differential temperature of 17°F.

Right side downstairs/Upstairs temperature drop

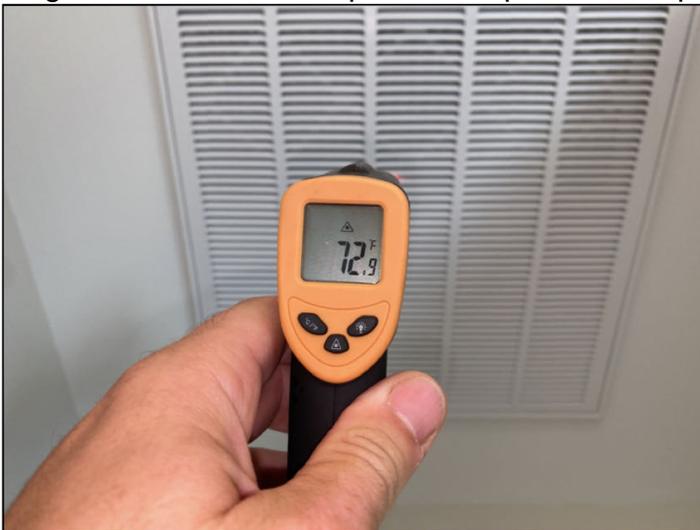
Left side downstairs temperature drop

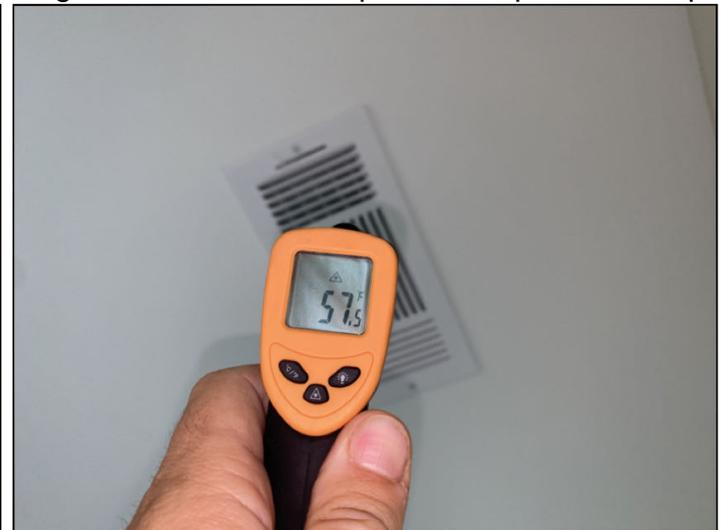
Left side downstairs temperature drop

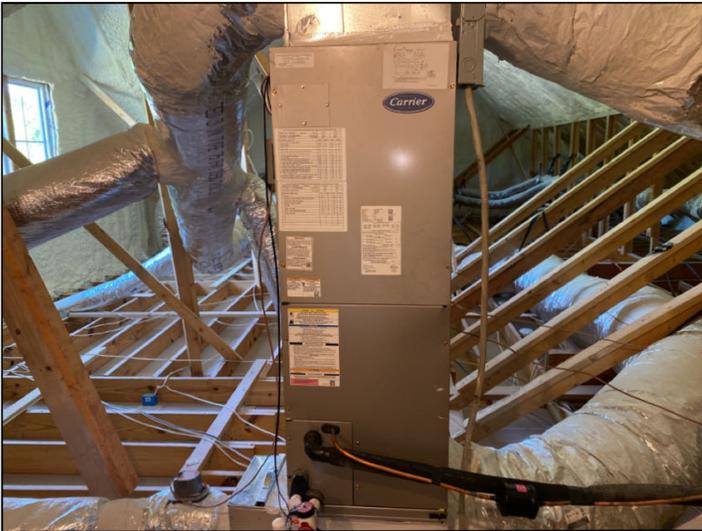
- The heating systems were functional at the time of the inspection. I recommend consulting with the seller regarding the service history of the systems.

Heater/air handler #1-Left side downstairs
