# ***Eagle Inspection Services, LLC***

## **Property Inspection Report**

123 ABC St, Anytown, AL 36830  
Inspection prepared for: Andrew Barber  
Date of Inspection: 5/22/2022 Time: 8:30am  
Age of Home: 2018 Size: 2500 sqft  
Weather: 85°/Sunny

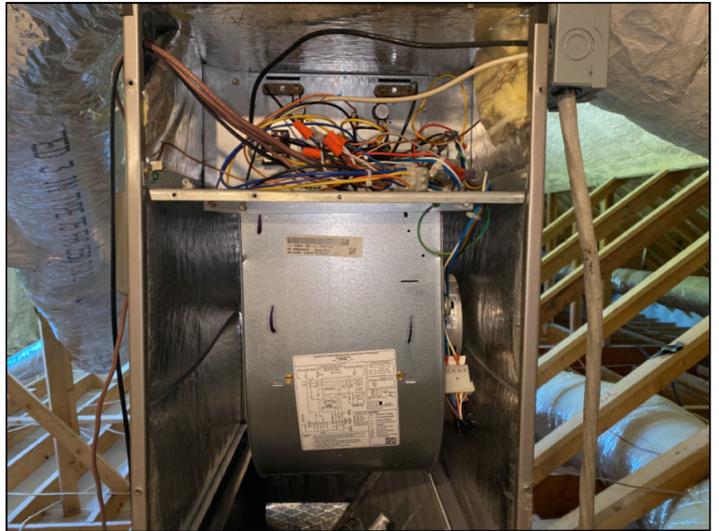
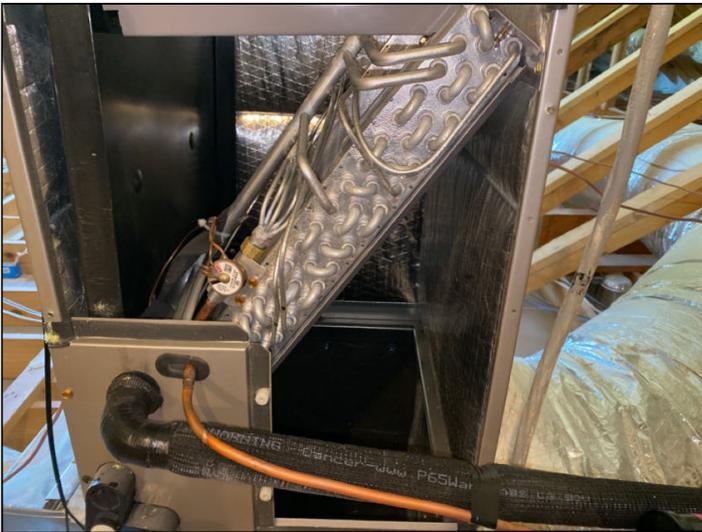
- The heating systems were functional at the time of the inspection. I recommend consulting with the seller regarding the service history of the systems.

Heater/air handler #1

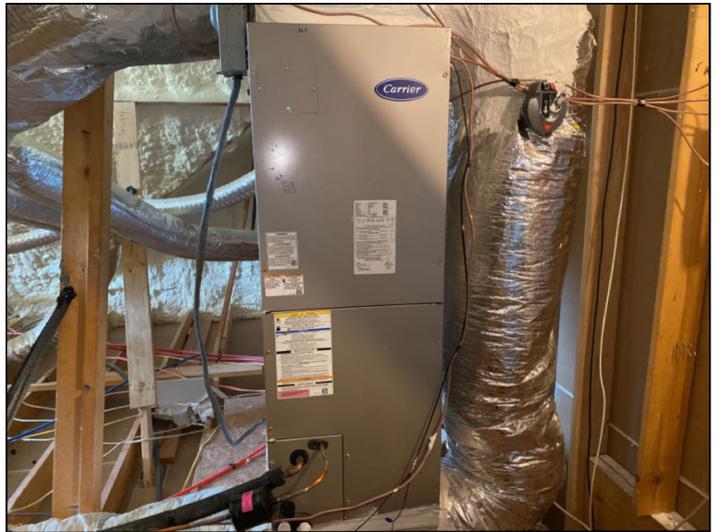
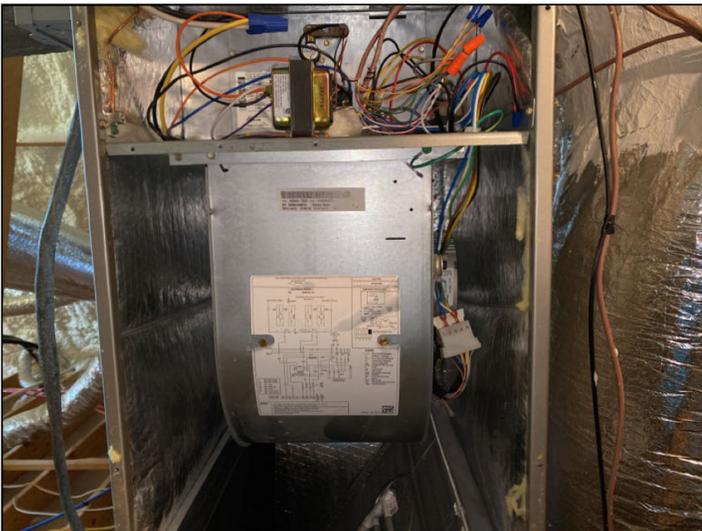
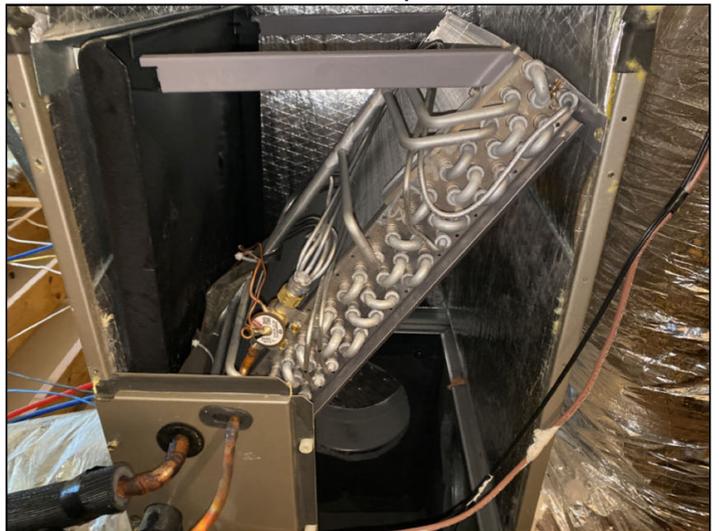
Heater/air handler #2-Right side downstairs/Upstairs

Heater/air handler #2

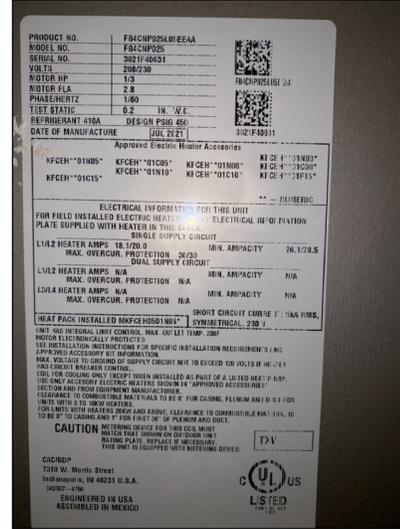
- Both heater/air handlers were approximately 2021 models.
- Heaters/air handlers generally have a 15-20 year life expectancy; however, most units can last much longer if properly maintained. I recommend an HVAC technician inspect and clean the system prior to the start of each season.

Heater/air handler #2-2021 model

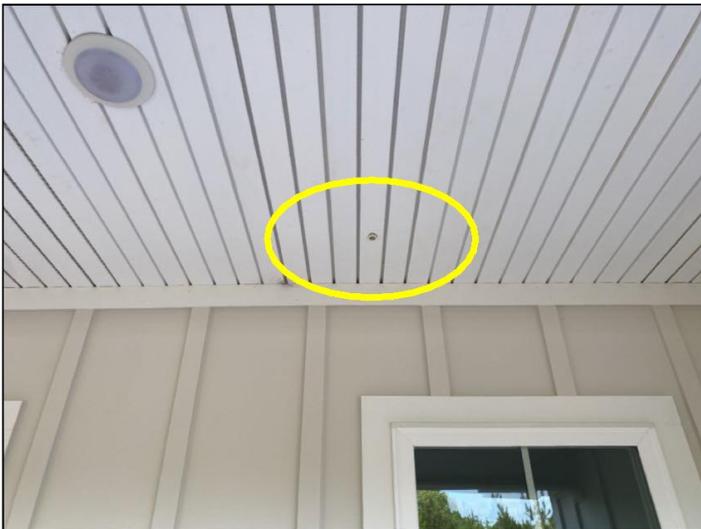
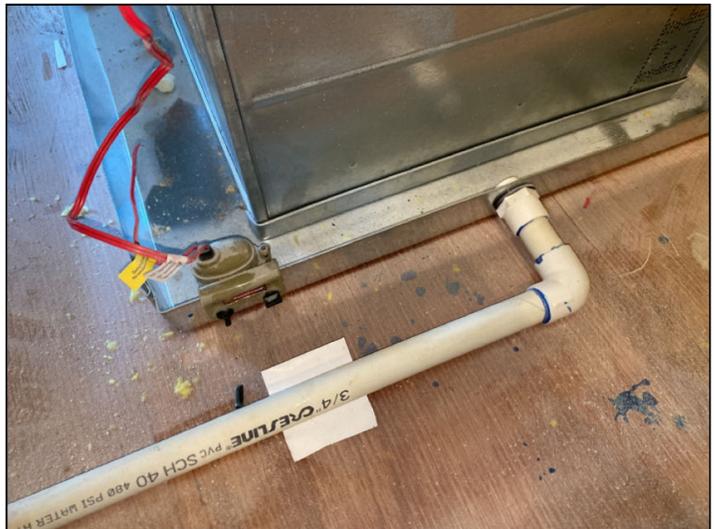
- The heater/air handler base appeared to be functional.
- FYI: There were auxiliary discharge pipes for the heater/air handler overflow drain pans that exit on the front and right sides of the structure. These pipes allow moisture to leave the structure if there is a backup in your condensate line or other problem with your HVAC system. If water is ever noticed discharging from these pipes, contact a qualified HVAC technician to have your system evaluated immediately.

Heater/air handler #1-Auxiliary discharge location

Heater/air handler #1

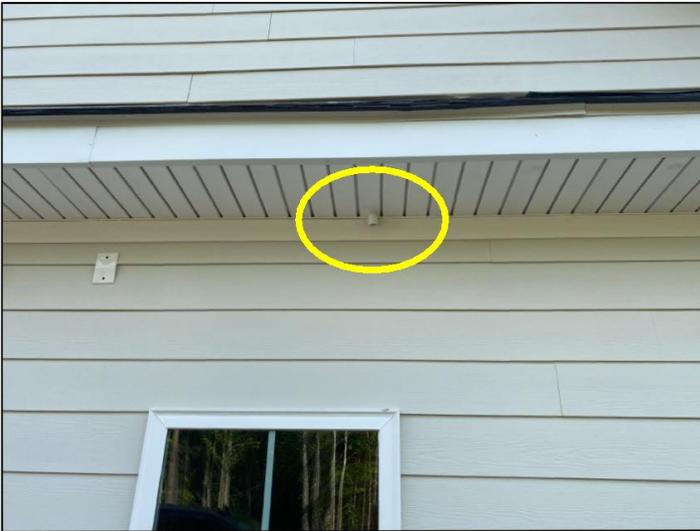
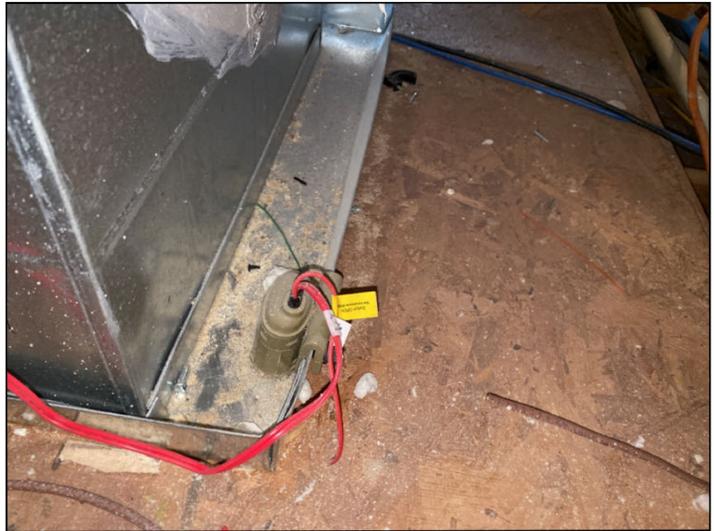
Heater/air handler #2-Auxiliary discharge location

Heater/air handler #2

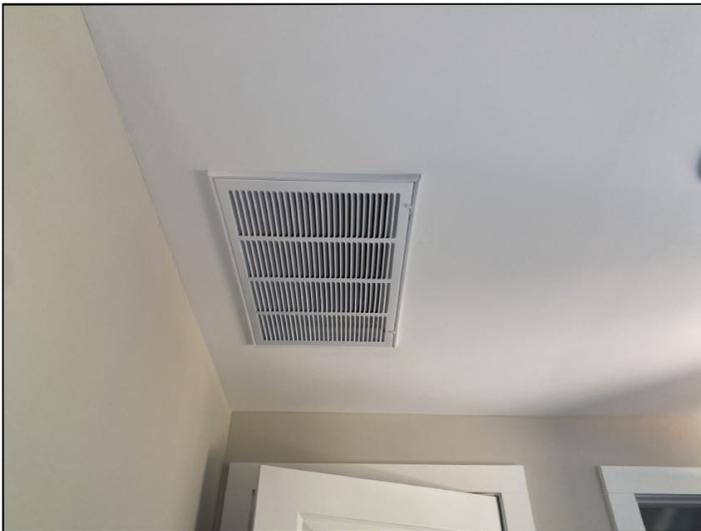
- **MAINTENANCE:** Air filter(s) should be inspected at least monthly and cleaned or replaced as required. Remember that dirty filters are the most common cause of inadequate heating or cooling performance.
- There were downstairs and upstairs air filters missing at the time of the inspection. Running the HVAC with no air filter can damage the system and will provide poor indoor air quality. I recommend replacing the air filters for proper operation.

Upstairs air filter missing

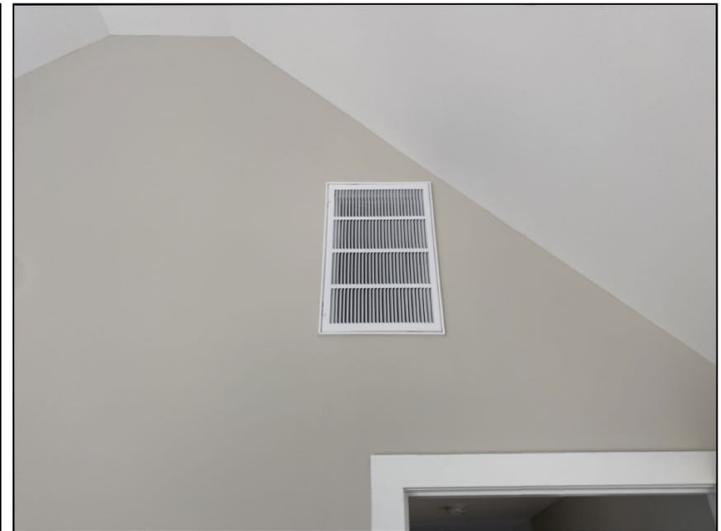
Downstairs air filter missing

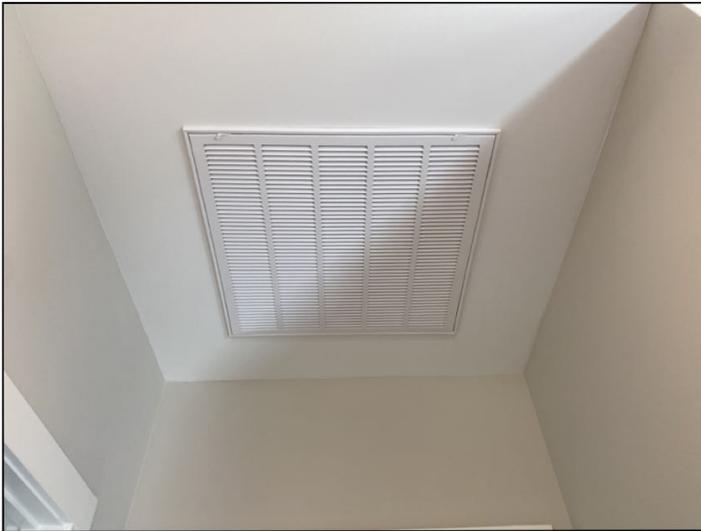
Downstairs left side air filter

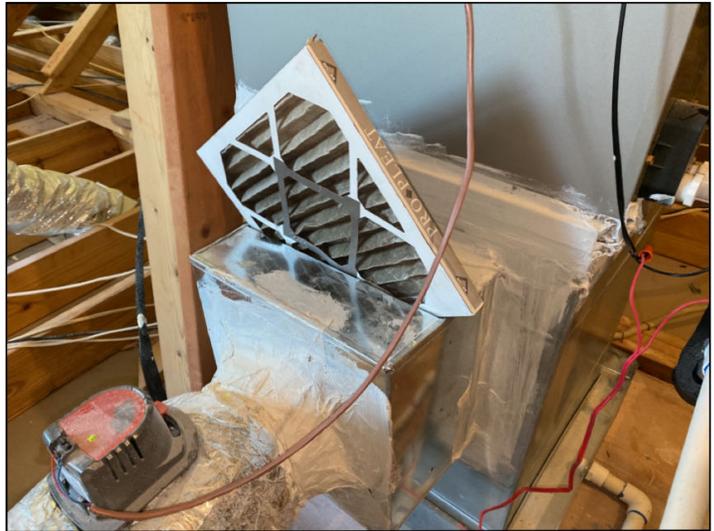
Heater/air handler #1 air filter

Heat/AC		
Page 44 Item: 11	Filters	<ul style="list-style-type: none"> <li>There were downstairs and upstairs air filters missing at the time of the inspection. Running the HVAC with no air filter can damage the system and will provide poor indoor air quality. I recommend replacing the air filters for proper operation.</li> </ul>

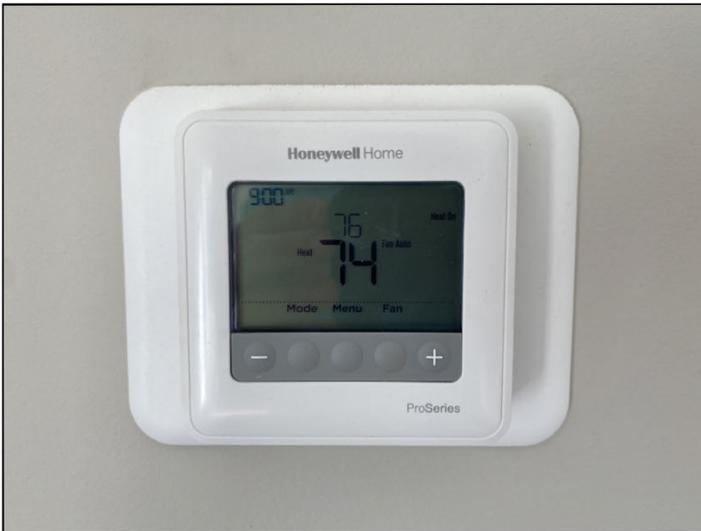
- Operated when tested. No deficiencies noted.
- Thermostats are not checked for calibration or timed functions.

Downstairs thermostat

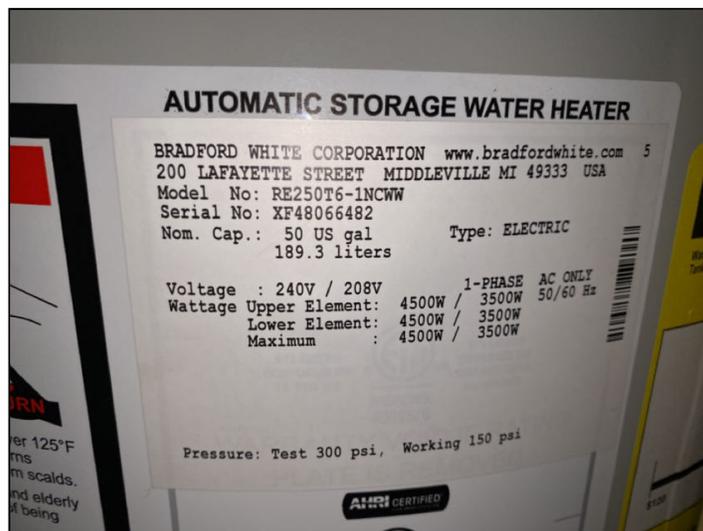
- The water heater was approximately a 2021 model.
- Water heater life expectancy is typically 10-12 years; however, units can last much longer if properly maintained. I recommend routine maintenance to prolong life.

2021 model/50 gallon

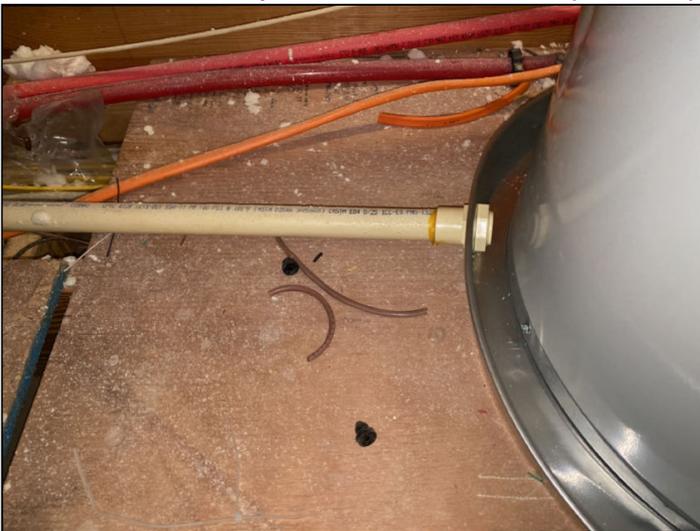
- The water heater base appeared functional.
- FYI: The water heater base auxiliary drain line terminates on the right side of the structure. If water is ever observed leaking from this pipe, it can be an indication that there is a problem with the water heater and you should contact a qualified plumber immediately to evaluate the system.

Water heater base discharge location

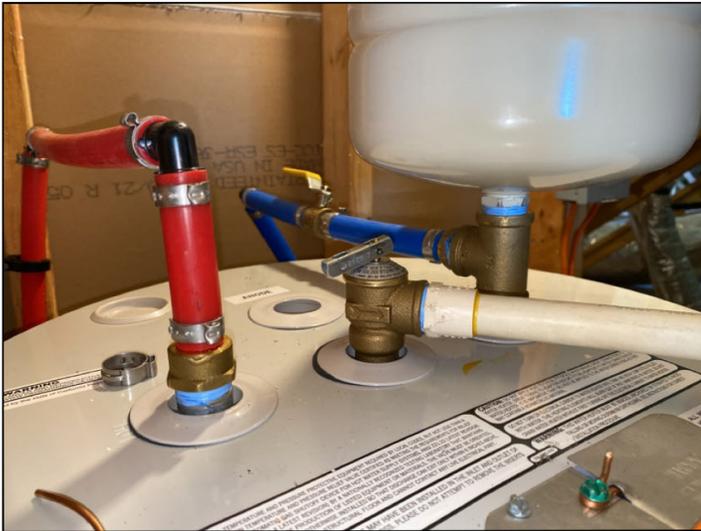
- UPGRADE: The **TPR valve** discharge pipe terminated into the water heater drain pan. The water heater drain pan is simply not designed to handle the amount of water that discharges during a TPR valve activation. While this termination location is common practice, I recommend extending the TPR valve discharge pipe to the exterior to prevent damage.

TPR valve discharges in water heater drain pan

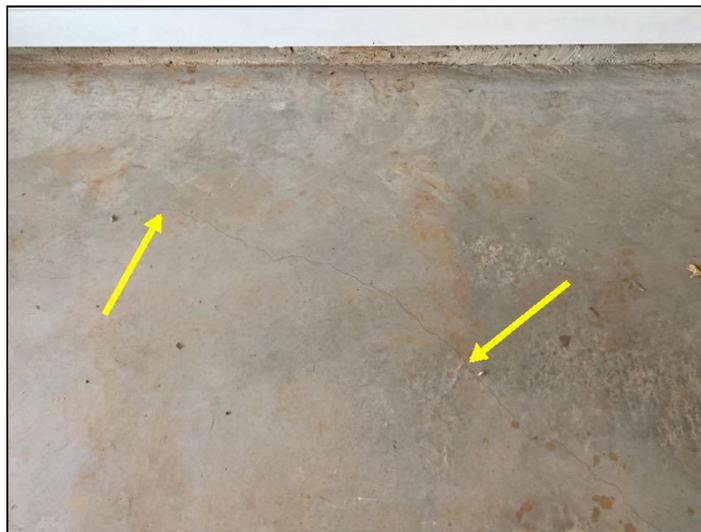
- Minor settlement, or "hairline" cracks noted. These should be monitored for expansion and sealed as necessary.

Typical concrete cracking

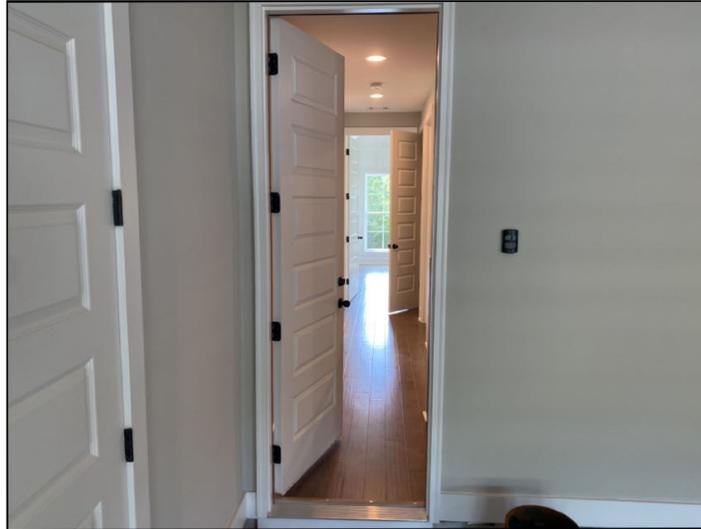
- Operated when tested.
- **UPGRADE:** There was no self-closing device on the door from the house leading to the garage. I recommend that one be installed in order to protect the residence against garage originated fires and carbon monoxide.

Recommend upgrading with self-closing device
