Eagle Inspection Services, LLC

Property Inspection Report

123 ABC St, Auburn, AL 36832
Inspection prepared for: Andrew Barber
Date of Inspection: 8/16/2022 Time: 08:30 AM
Age of Home: 2010 Size: 3202 sqft
Weather: 83°/Sunny

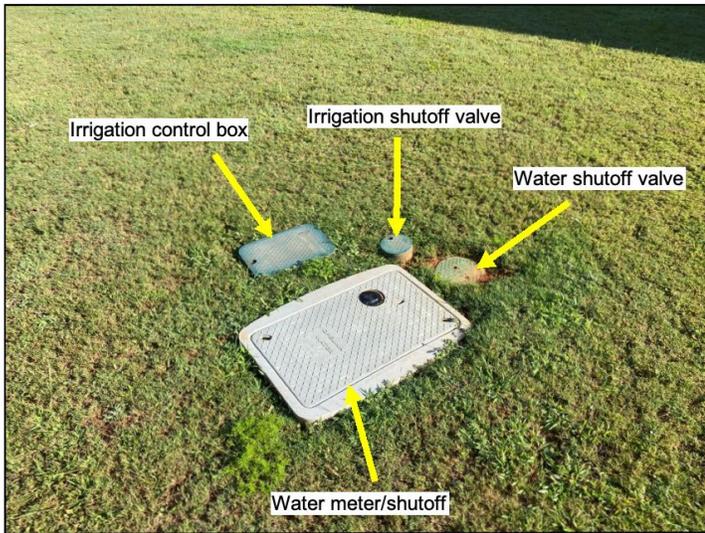
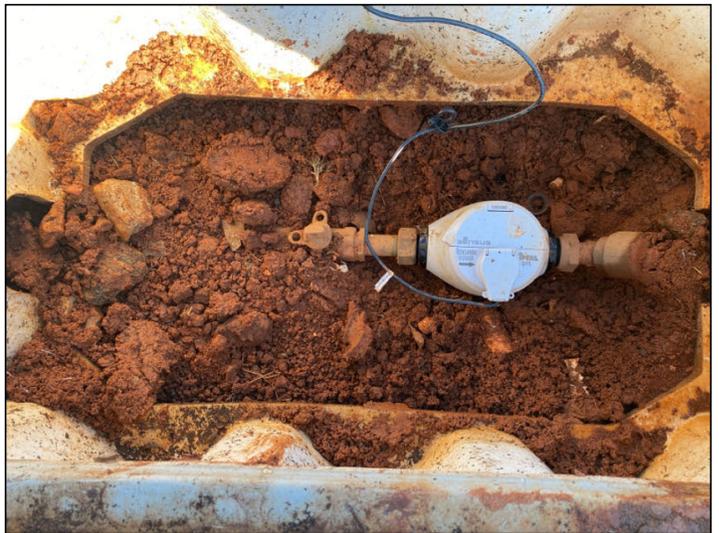
Water meter/shutoff

- The water meter/shutoff was located in the front yard.
- **DWV** cleanouts were located on the front and right sides of the structure.

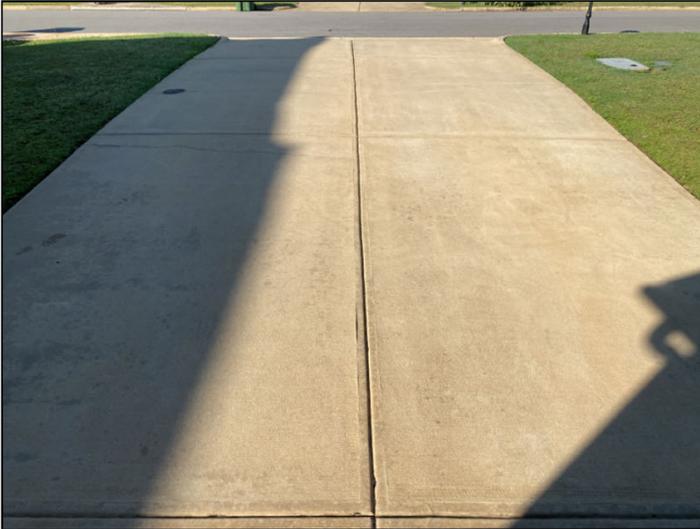
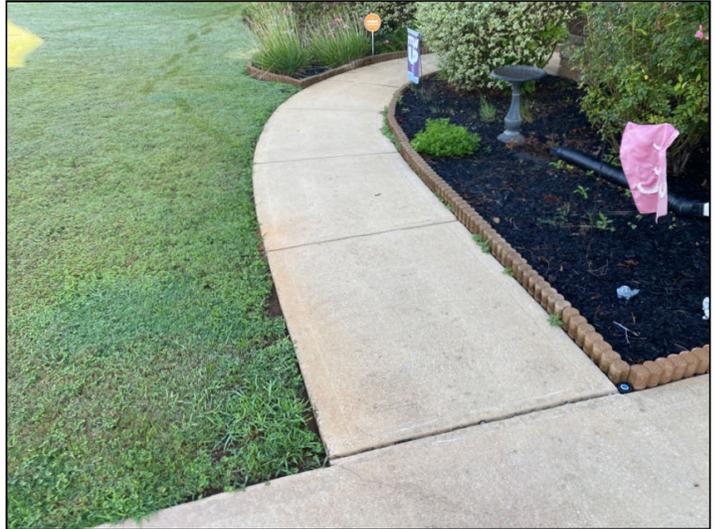
- The driveway and walkways were in acceptable condition with typical cracking observed.
- **MAINTENANCE:** Minor settlement, or "hairline" cracks in driveways are normal for properties of any age. They should, however, be monitored for expansion and sealed as necessary.

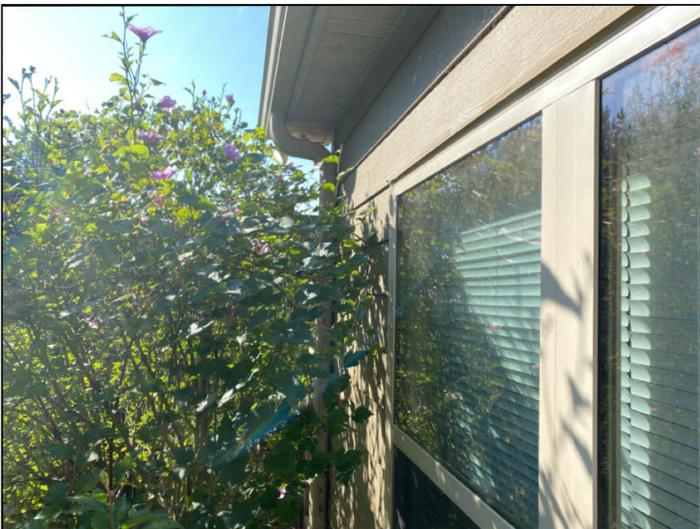
Vegetation touching structure

- **MAINTENANCE TIP:** When landscaping, keep plants, even at full growth, at least a foot (preferably 18 inches) from house siding and windows. Keep trees away from foundation and roof. Plants in contact or close proximity to the home can provide pathways for wood destroying insects and moisture, as well as abrade and damage siding, screens and roofs.
- There was vegetation touching the structure. I recommend pruning or removing any plants or trees that are in contact or close proximity to the home to eliminate pathways of wood destroying insects and moisture.

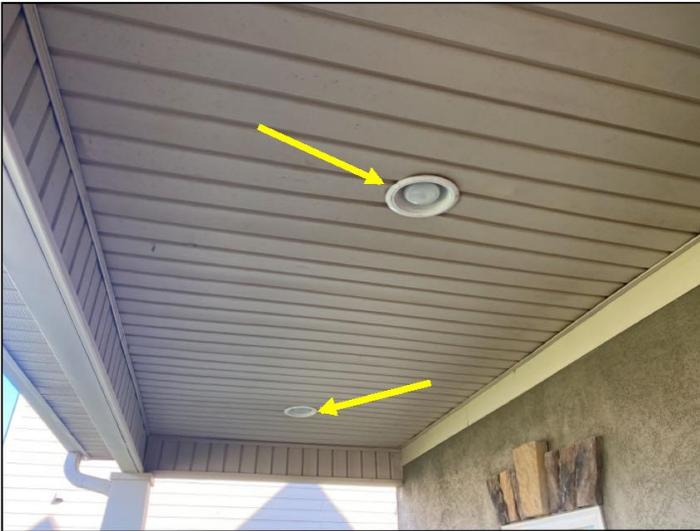
- Two front patio lights were not working at the time of the inspection. This is probably due to blown bulbs. I recommend checking for function prior to closing.
- There was a damaged extension cord being used to run power to the storage shed. The damaged cord is an electrocution hazard, and extension cords are temporary wiring. Approved outside wiring should be installed for safety.

Front patio lights not working

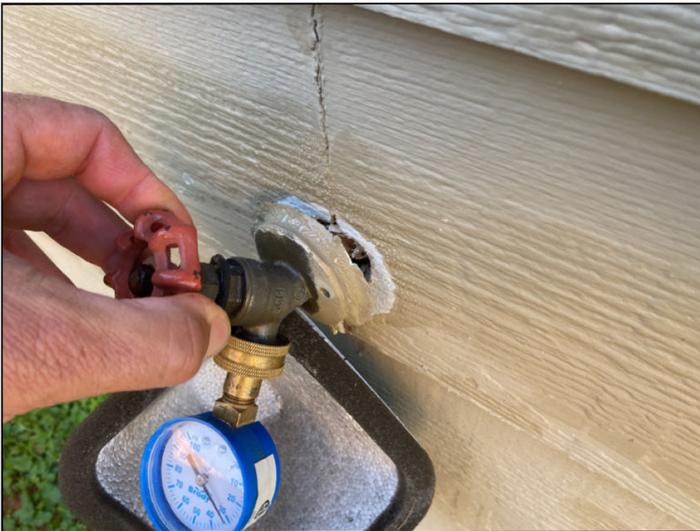
- The exterior faucets were loose at the structure. I recommend securing the faucets to prevent possible damage to the supply line.

Exterior faucet loose

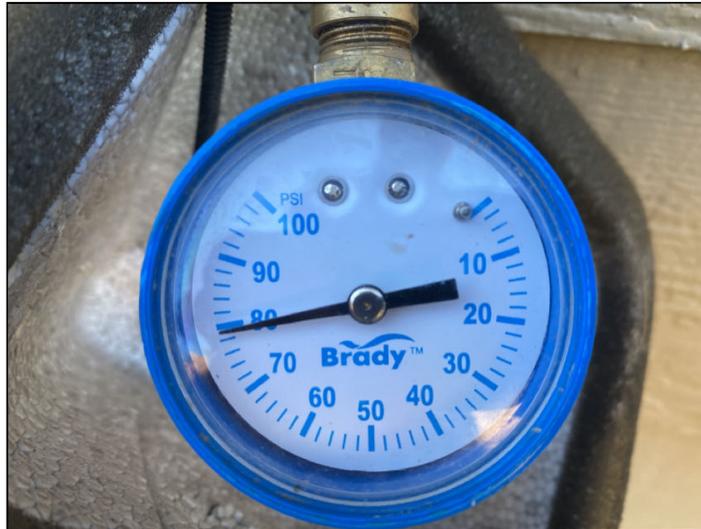
- The water pressure was measured at 80psi. Normal residential water pressure is between 40-80psi.

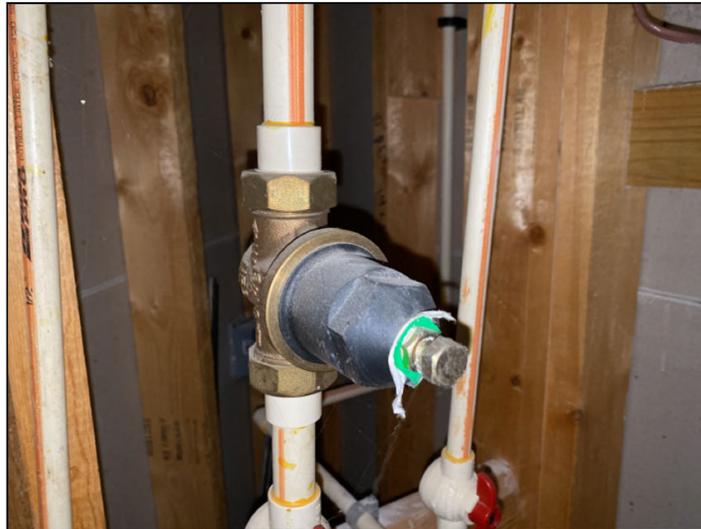
Pressure regulator

- There was a **pressure regulator** located at water heater #2.

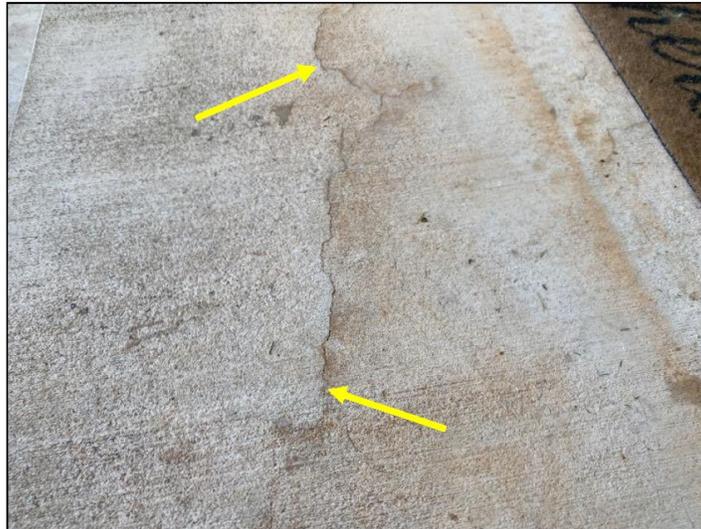
- Minor settlement, or "hairline" cracks noted. These should be monitored for expansion and sealed as necessary.

Typical concrete cracking

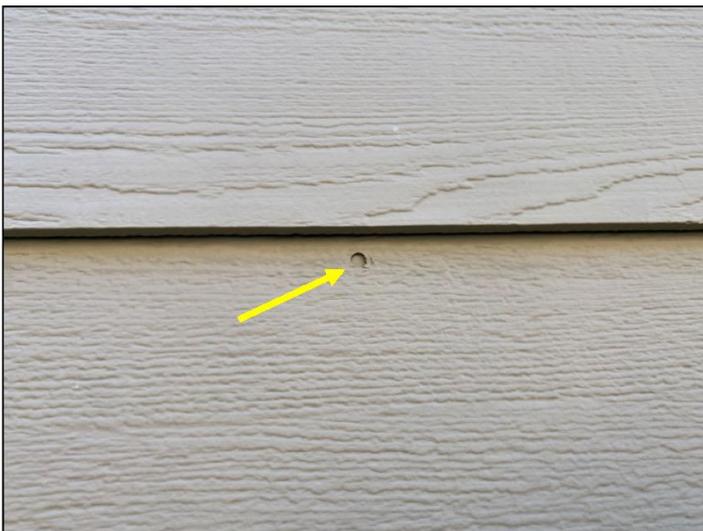
- The exterior siding was in acceptable condition with wear consistent of its age.
- **MAINTENANCE:** I recommend routine monitoring of the caulking around doors, windows and siding. These areas should be properly sealed to prevent moisture intrusion and keep hot and cold air inside during the respective winter and summer months.
- **There were several small nail holes in the exterior siding on the left side of the structure. I recommend sealing these holes as necessary to prevent moisture intrusion.**

Nail hole

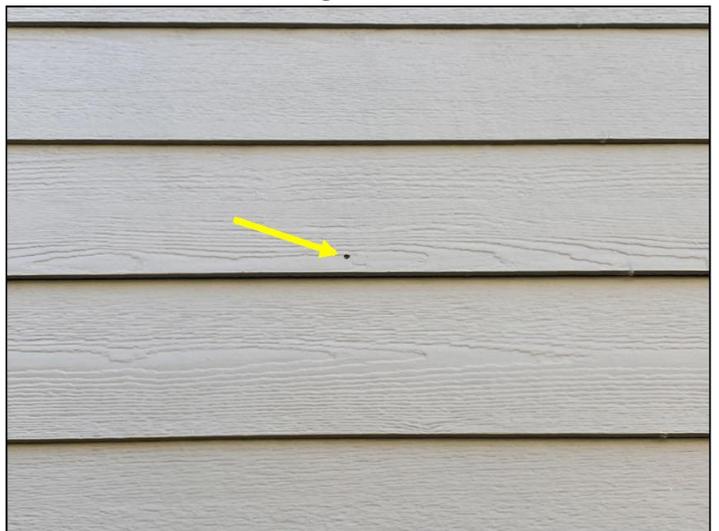
Nail hole

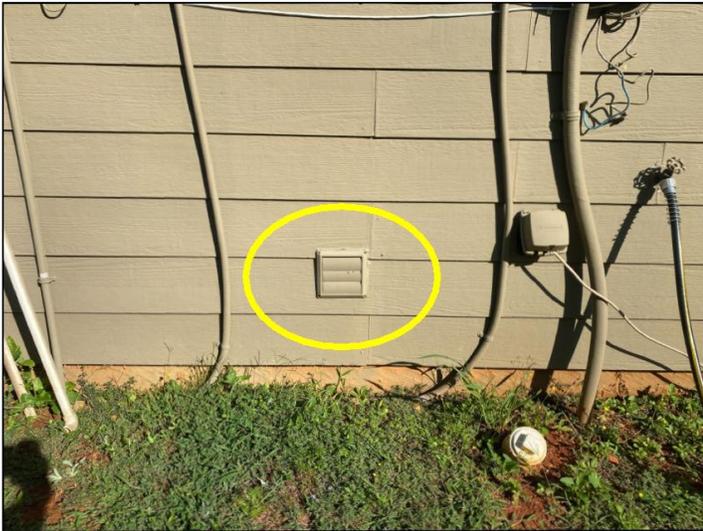
Exterior dryer vent

- The exterior dryer vent was located on the right side of the structure.
- MAINTENANCE: I recommend routine cleaning to prevent lint buildup.

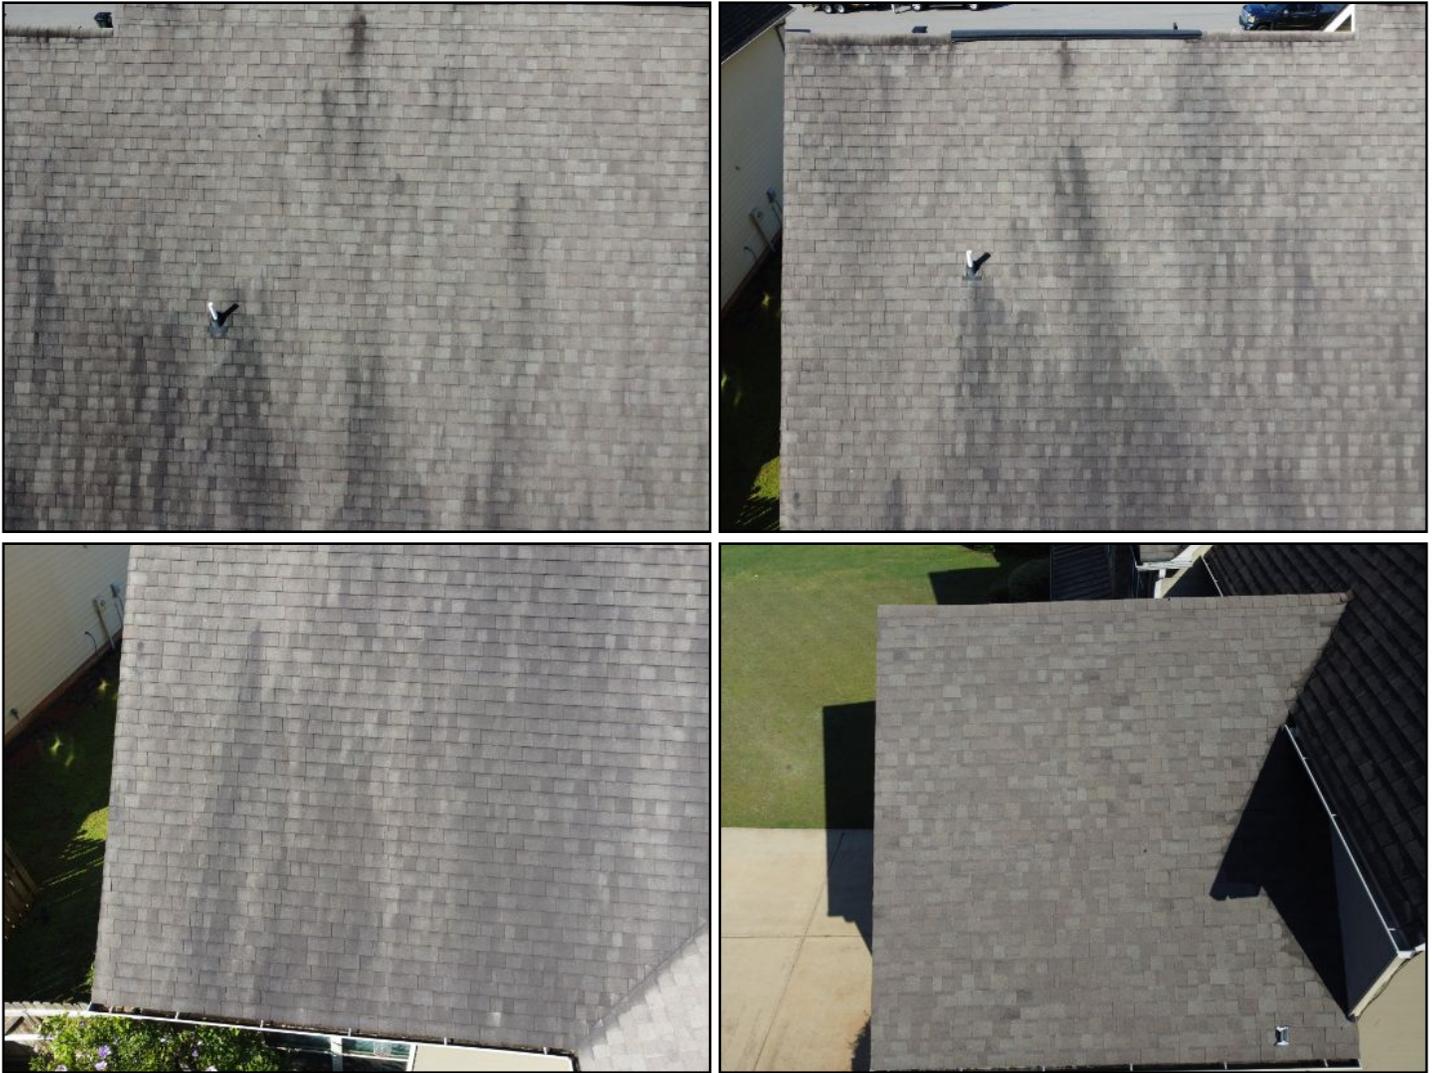
- The roof covering was in acceptable condition with wear consistent of its age, except where noted.
- MAINTENANCE: Roof systems should be periodically cleaned and maintained. Proper maintenance of the roof will help prolong the life of the surfaces.
- FYI: There were four scars on the shingles at the bottom of the dormer. These scars did not appear to be leaking at the time of the inspection; however, I recommend sealing these scars to prevent future moisture intrusion.

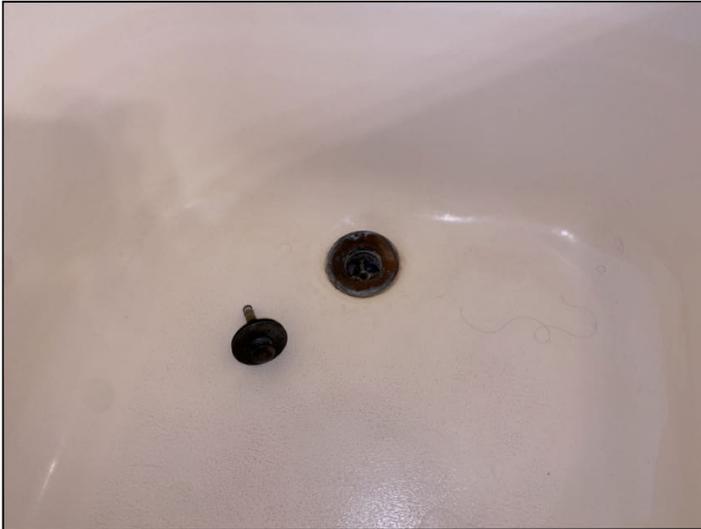
- The tubs were functional during the inspection.
- The stopper to the tub in upstairs bathroom #1 was inoperable at the time of the inspection. I recommend correction for proper operation.
- There were chips in the tub enamel in downstairs bathroom #2. I recommend repair to prevent damage.

Tub stopper inoperable in upstairs bathroom #1

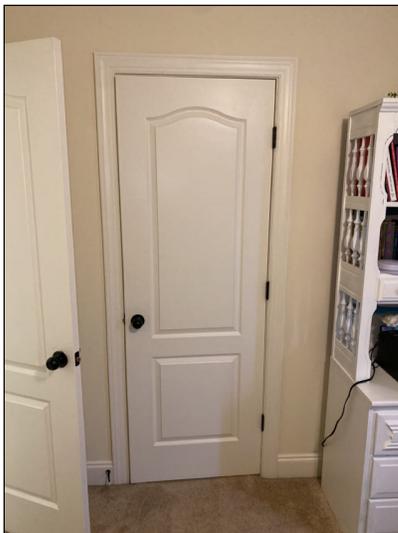
- Operated when tested. No deficiencies found, except where noted.
- There were interior doors that needed to be repaired/adjusted to function properly. I recommend repair/adjustment for proper operation.

Closet door in upstairs bedroom #1 rubs frame

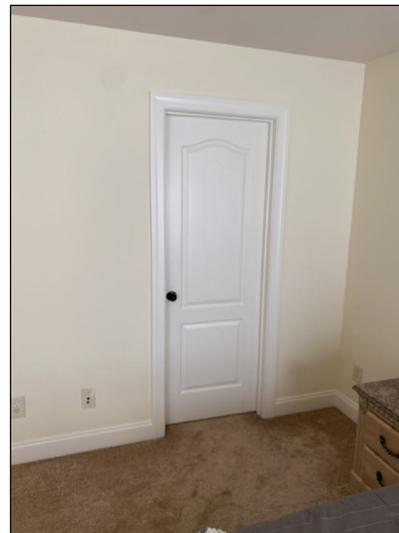
Closet door in upstairs bedroom #3 rubs frame

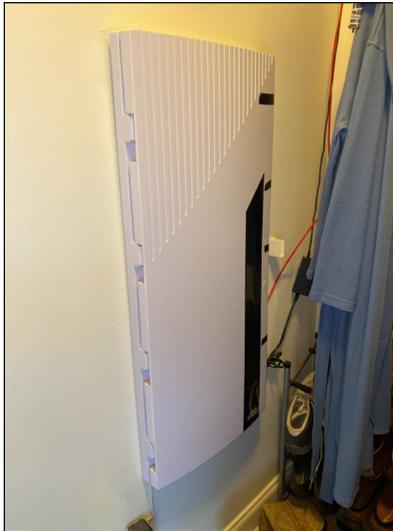
- FYI: The Open House panel located in the closet of downstairs bathroom #2 is a wiring panel for all the audio and communication (telephone, data, TV) wiring in the house.

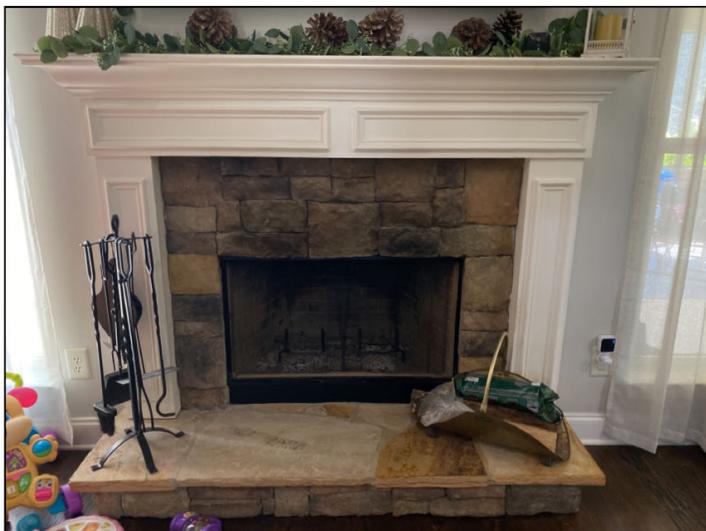
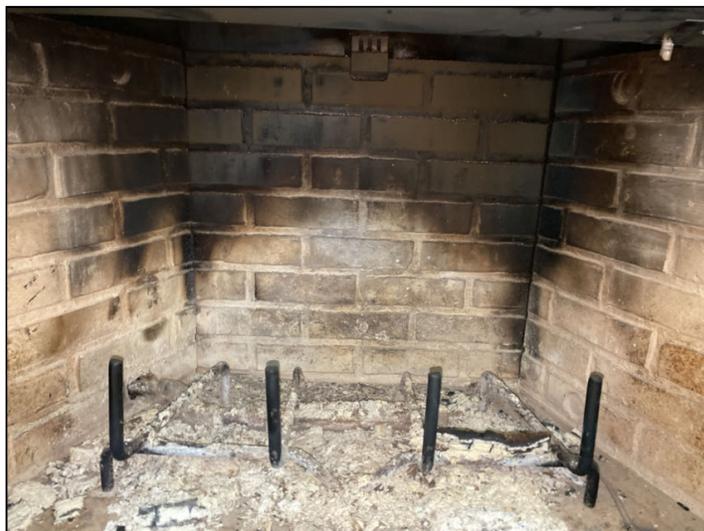
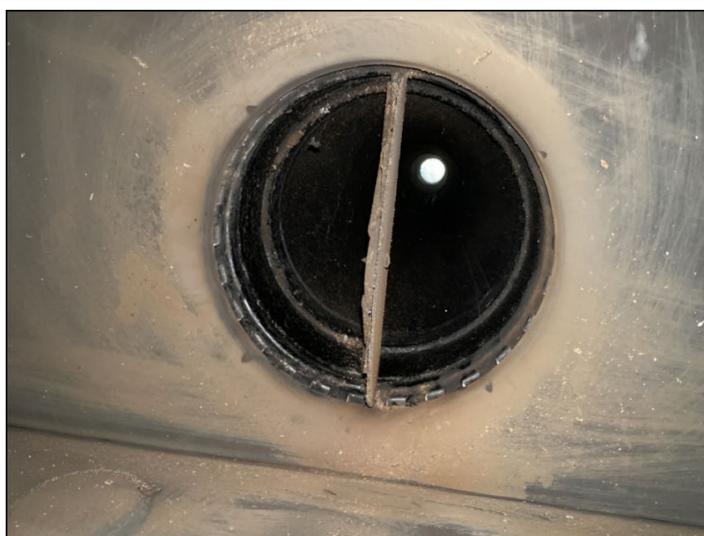
- I was able to conduct a limited review of the fireplace and chimney and found no deficiencies. I recommend a full review of the fireplace and chimney by a qualified chimney sweep prior to first use.

- **UPGARDE:** I recommend installing glass doors on the fireplace. Glass doors can reduce heating and cooling costs. Glass doors radiate heat into a room better than a fireplace without doors. Glass doors also offer protection from sparks or logs tumbling out of the fireplace, and prevent children from getting too close to the fireplace.

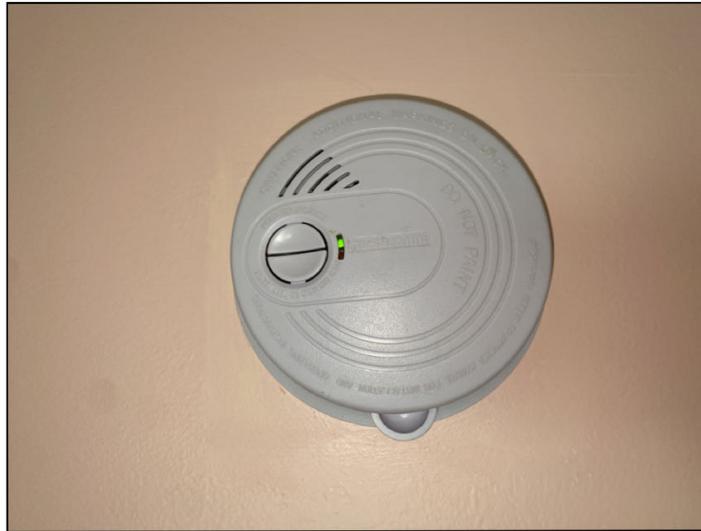
Smoke detector

- Smoke detectors were present and functional at the time of the inspection. No CO detectors were present.
- MAINTENANCE: I recommend Smoke/CO detectors be tested and have batteries changed twice yearly. It is recommended that Smoke/CO detectors be installed and maintained on every level of the home, in every bedroom, and outside each sleeping area.
- UPGRADE: No Carbon Monoxide (CO) detectors were present. If gas appliances, a wood burning fireplace or an attached garage exists, it is highly recommended that CO detectors be installed and maintained throughout the structure. CO is a poisonous gas that is dangerous because it is odorless, colorless, and tasteless.

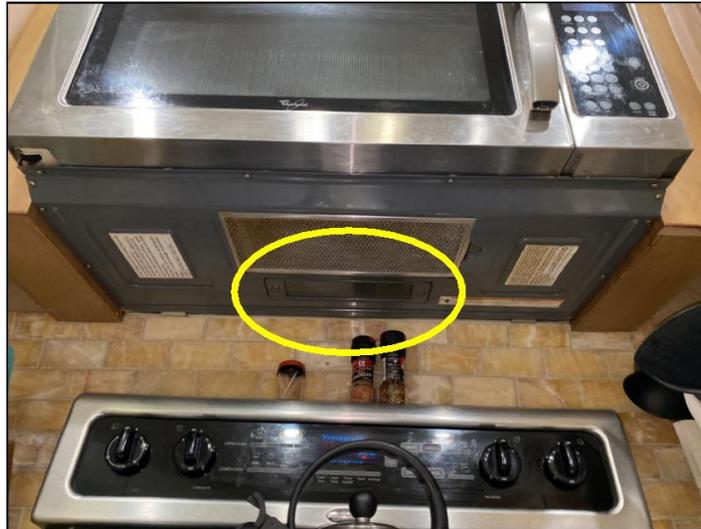
- The cooktop light was inoperable at the time of the inspection. This is probably due to a blown bulb(s). I recommend replacing the bulb(s) and checking for function prior to closing.

Cooktop light not working

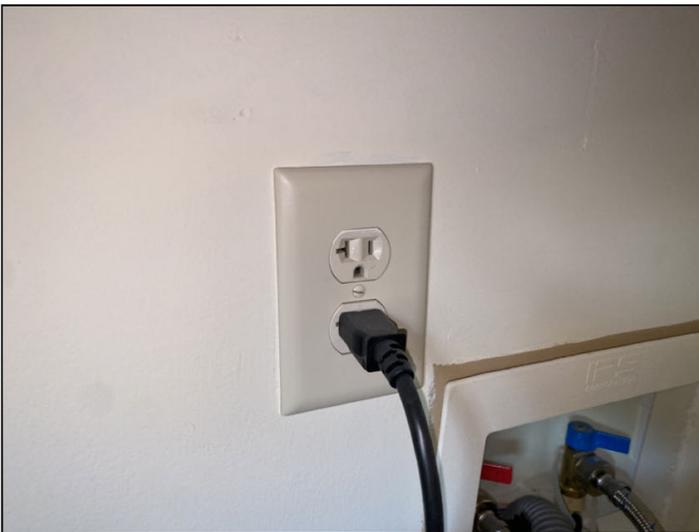
120/volt washing machine electrical outlet

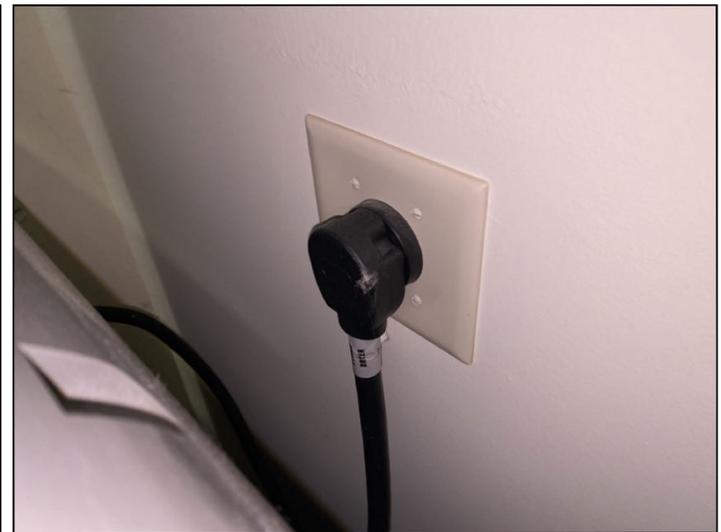
240/volt 4-prong dryer electrical outlet

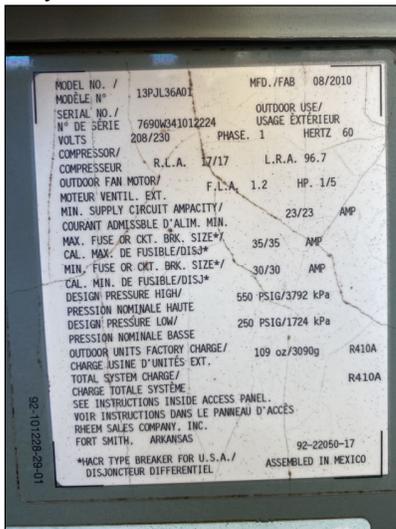
A/C unit #1-2010 model/3 ton capacity

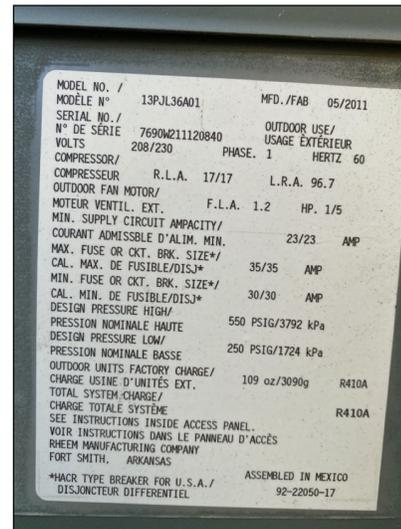
A/C unit #2-2011 model/3 ton capacity

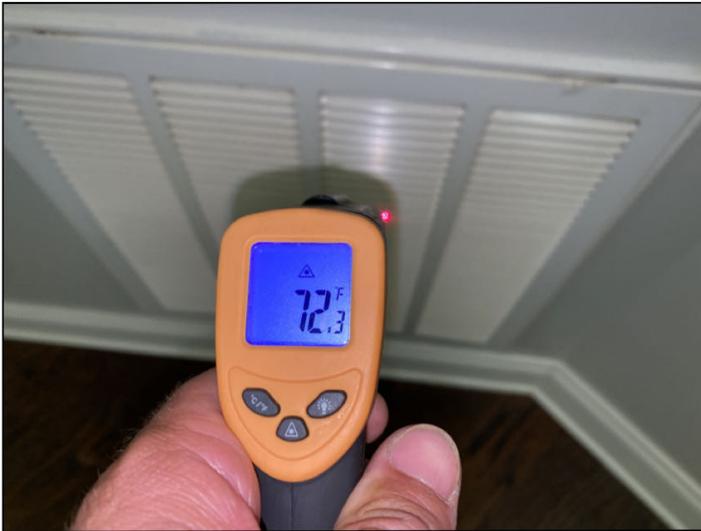
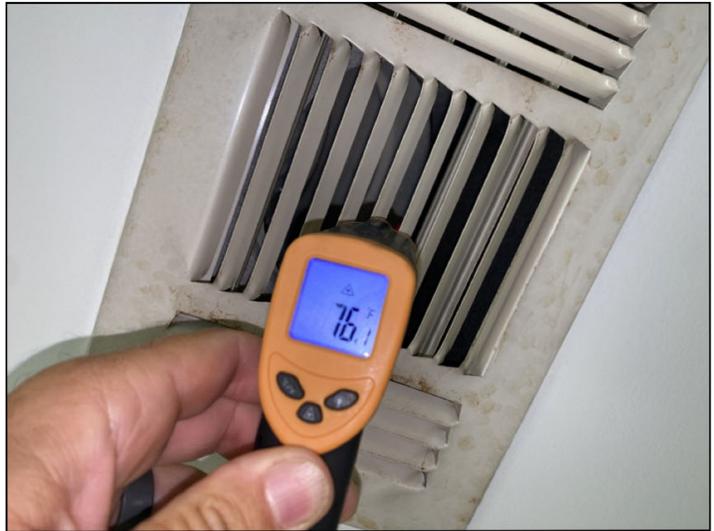
- The typical temperature differential split between supply and return air in air conditioners of this type is 15°-20°F.
- The upstairs A/C system responded and achieved an acceptable differential temperature of 18°F.
- **The downstairs A/C system failed by not achieving any drop in temperature. I recommend review by a qualified HVAC technician.**

Downstairs temperature drop

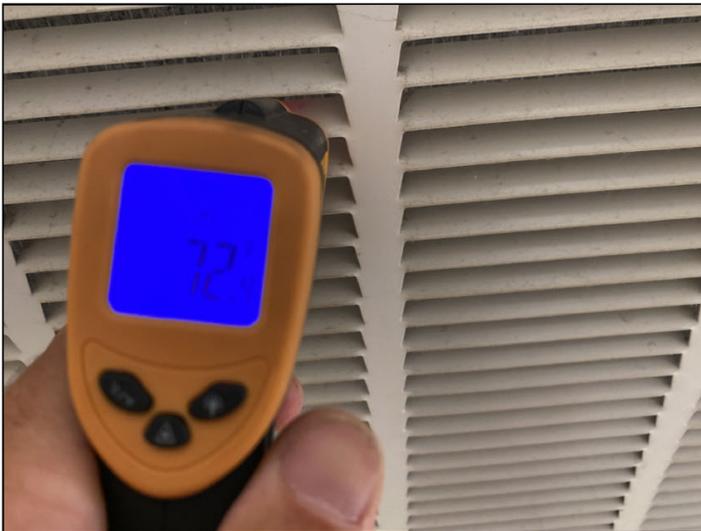
Upstairs temperature drop

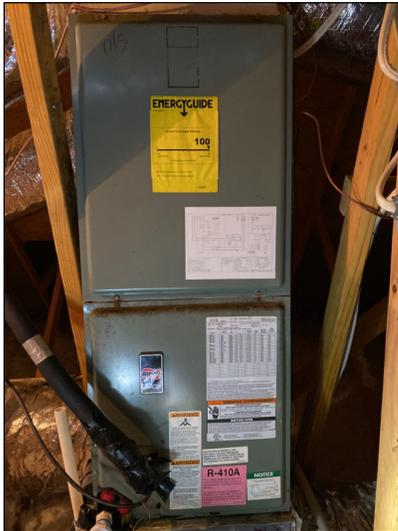
Heater/air handler #1-Downstaors

- The heating systems were functional at the time of the inspection. I recommend consulting with the seller regarding the service history of the systems.

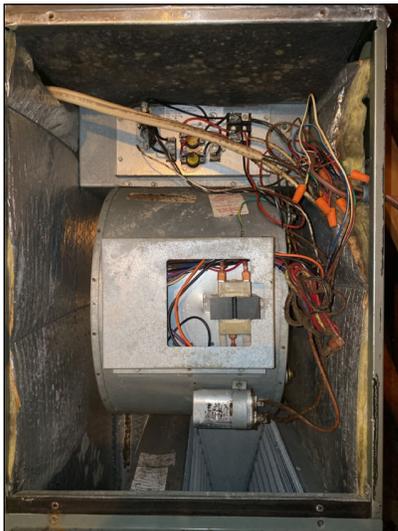
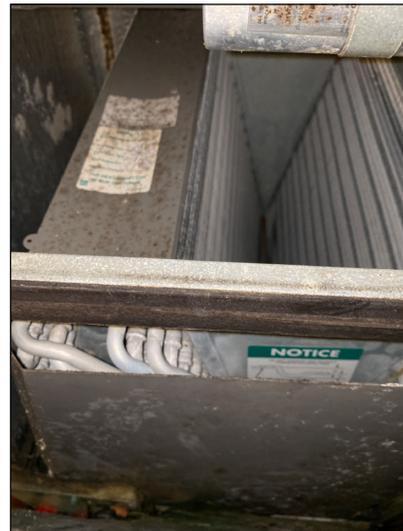
- Heaters/air handlers generally have a 15-20 year life expectancy; however, most units can last much longer if properly maintained. I recommend an HVAC technician inspect and clean the system prior to the start of each season.
- Heater/air handler #1 was approximately a 2009 model.
- Heater/air handler #2 was approximately a 2011 model.

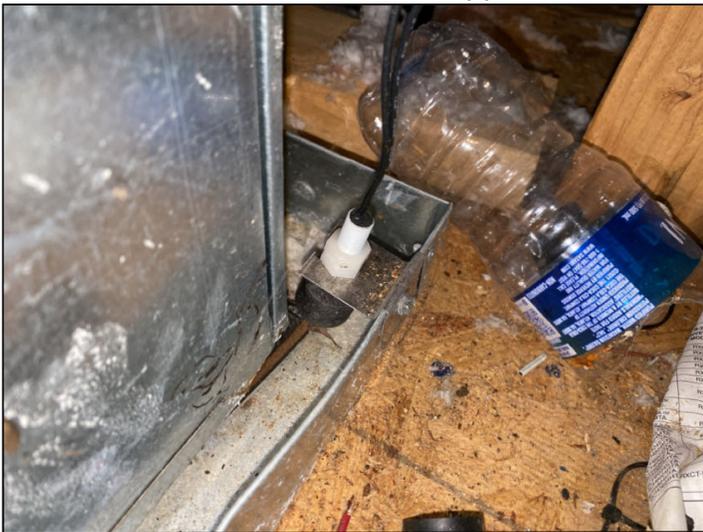
- The heater/air handler bases appeared to be functional.

Heater/air handler #1-Condensate overflow switch

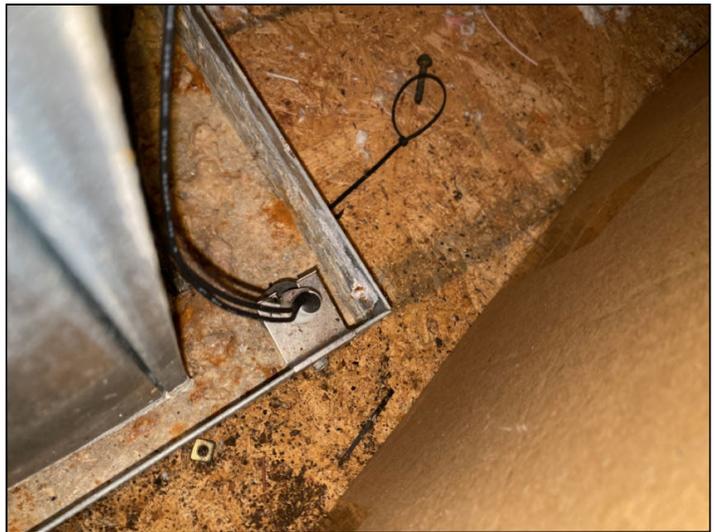
Heater/air handler #2-Condensate overflow switch

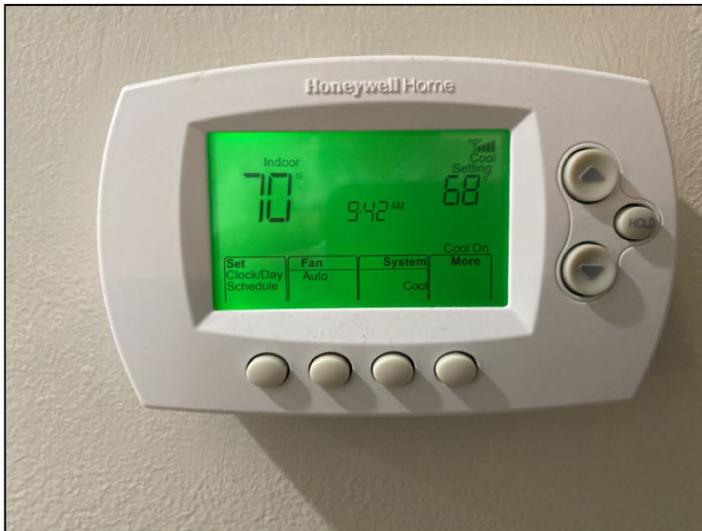
Downstairs thermostat

- Operated when tested. No deficiencies noted.
- Thermostats are not checked for calibration or timed functions.

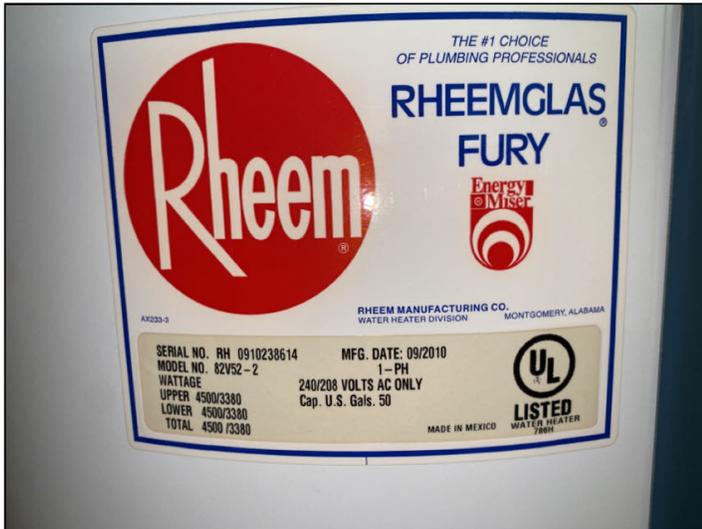
- The water heaters were approximately 2010 models.
- Water heater life expectancy is typically 10-12 years; however, units can last much longer if properly maintained. I recommend routine maintenance to prolong life.
- **FYI: The water heaters are nearing the end of their average service life. While the water heaters may still be functional, they could fail at any time. I recommend budgeting for eventual replacement and evaluation by a qualified plumber if necessary.**

Water heater #1-2010 model/50 gallon

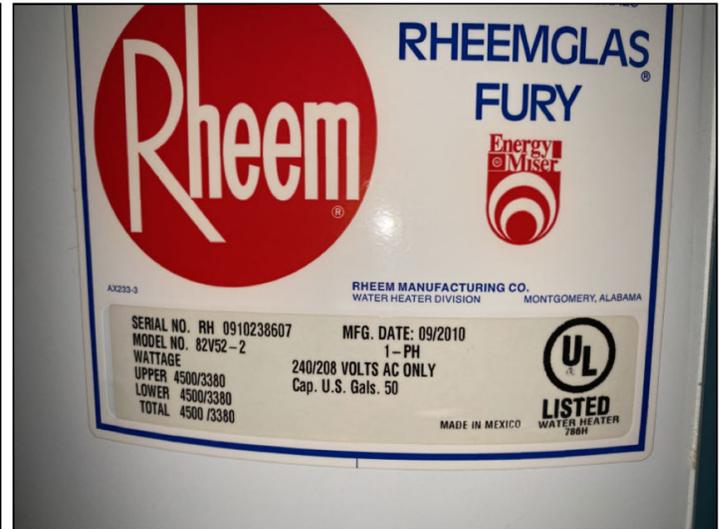
Water heater #2-2010 model/50 gallon

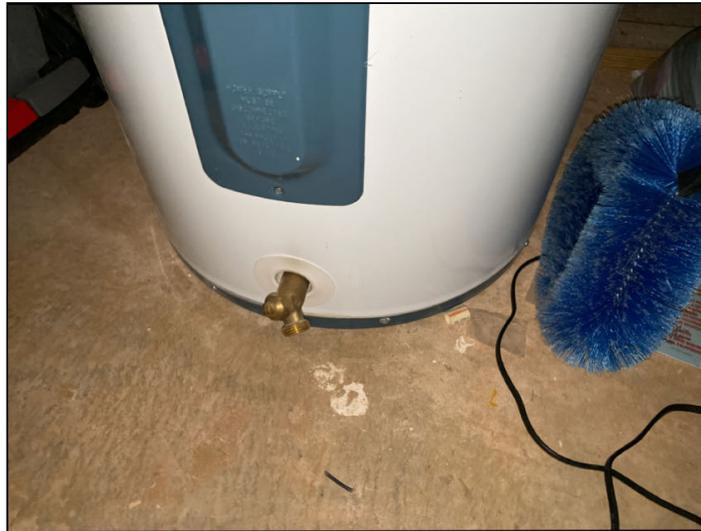
- The water heater base appeared functional.
- **UPGRADE:** There was no drain pan present under water heater #2. A drain pan is generally recommended under your water heater tank, especially if your water heater is located inside your home. The drain pan should include a 3/4" drain line to an approved location.

Water heater #2-No drain pan

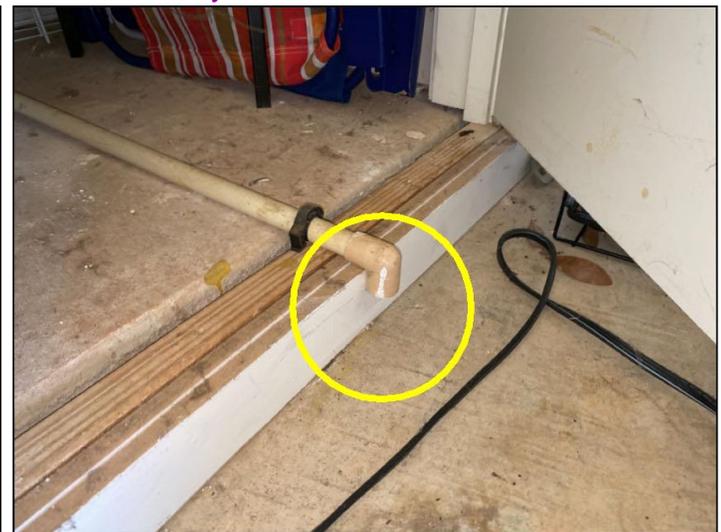
- The **TPR valve** and discharge pipe appeared to be in satisfactory condition at the visible portions.
- **FYI:** The TPR valve discharge pipe for water heater #1 terminates in the garage. If water is ever observed leaking from this pipe, it can be an indication that this safety valve is failing and you should contact a qualified plumber immediately to evaluate the system.

TPR valve discharge location

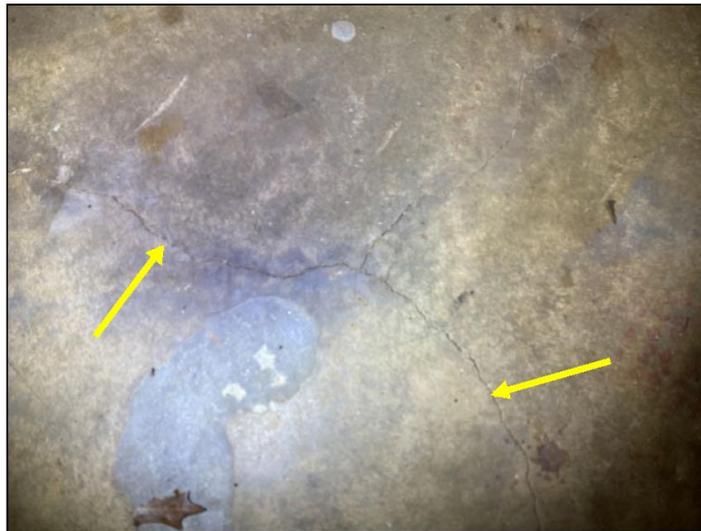
- Minor settlement, or "hairline" cracks noted. These should be monitored for expansion and sealed as necessary.

Typical concrete cracking

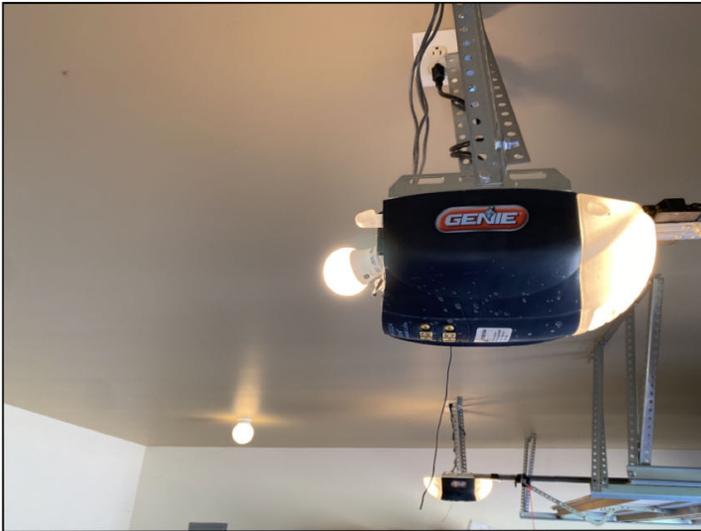
- GFCI outlets were in place and operational at the time of the inspection.
- There were two fixture globes missing in the garage. I recommend replacing the globes for safety.

Garage door opener fixture globe missing

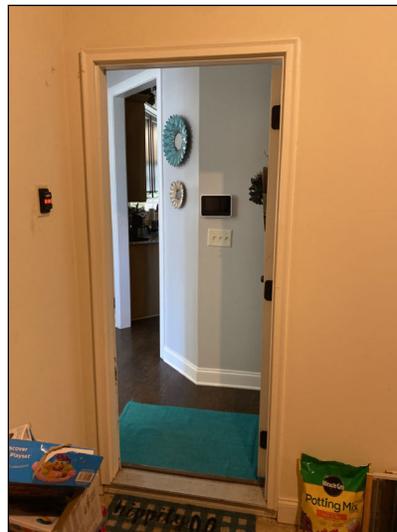
- Operated when tested.
- **UPGRADE:** There was no self-closing device on the door from the house leading to the garage. I recommend that one be installed in order to protect the residence against garage originated fires and carbon monoxide.

Recommend upgrading with self-closing device
